**REPORT TO  
GCS (PTY) LTD ON A PRELIMINARY  
GEOTECHNICAL ASSESSMENT OF  
SEAFACING SLOPE AND CLIFF  
FACE STABILITY DURING  
BEACH MINING OPERATIONS,  
TORMIN MINERAL SANDS PROJECT,  
WEST COAST, RSA**

**Reference**  
3102

**Date**  
October 2006

**DAVIES  
LYNN &  
PARTNERS**  
(PROPRIETARY) LIMITED

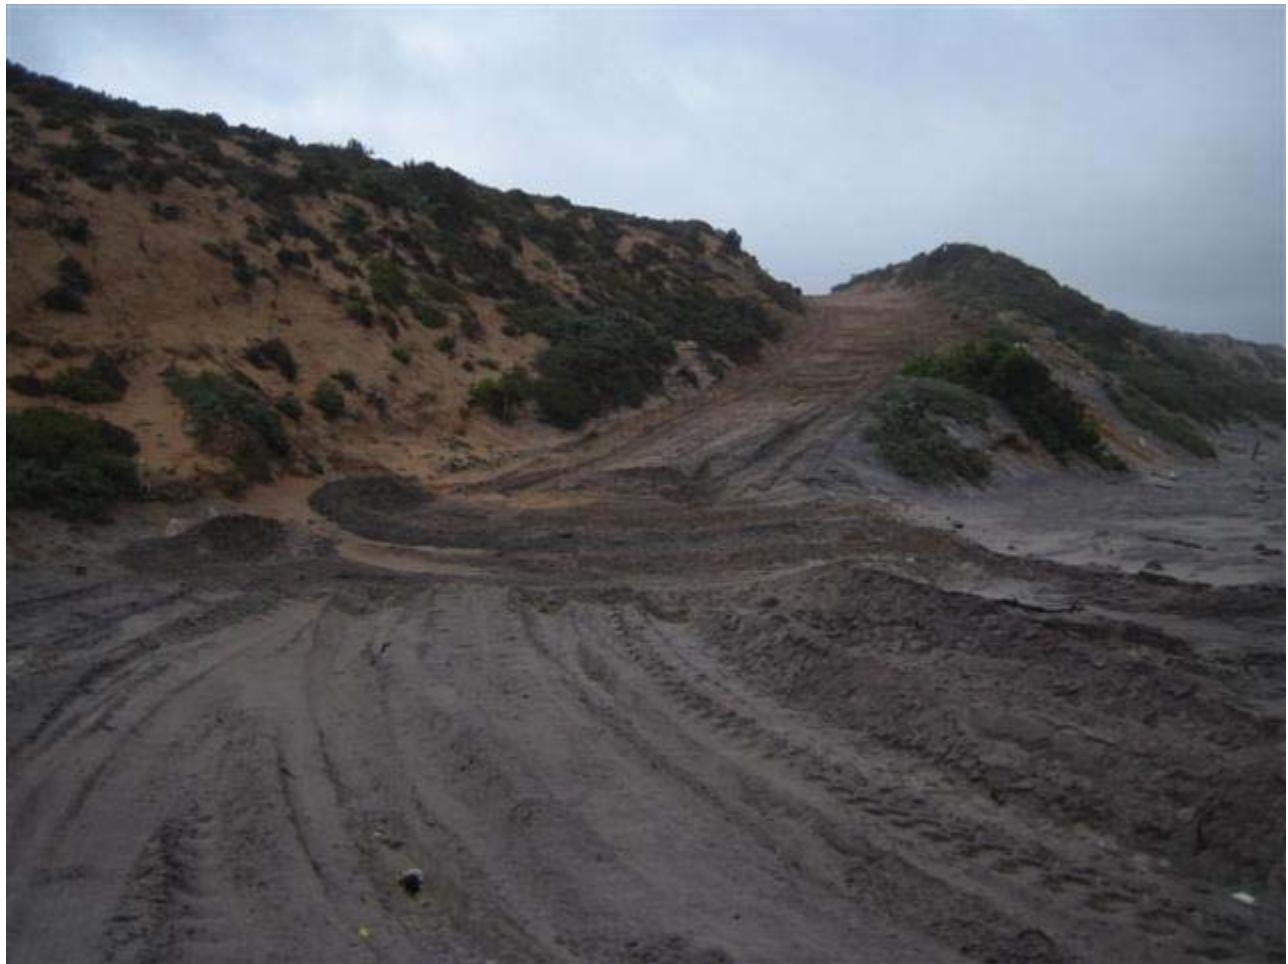
**PLATE 26 – P92**

**Well maintained beach access road**

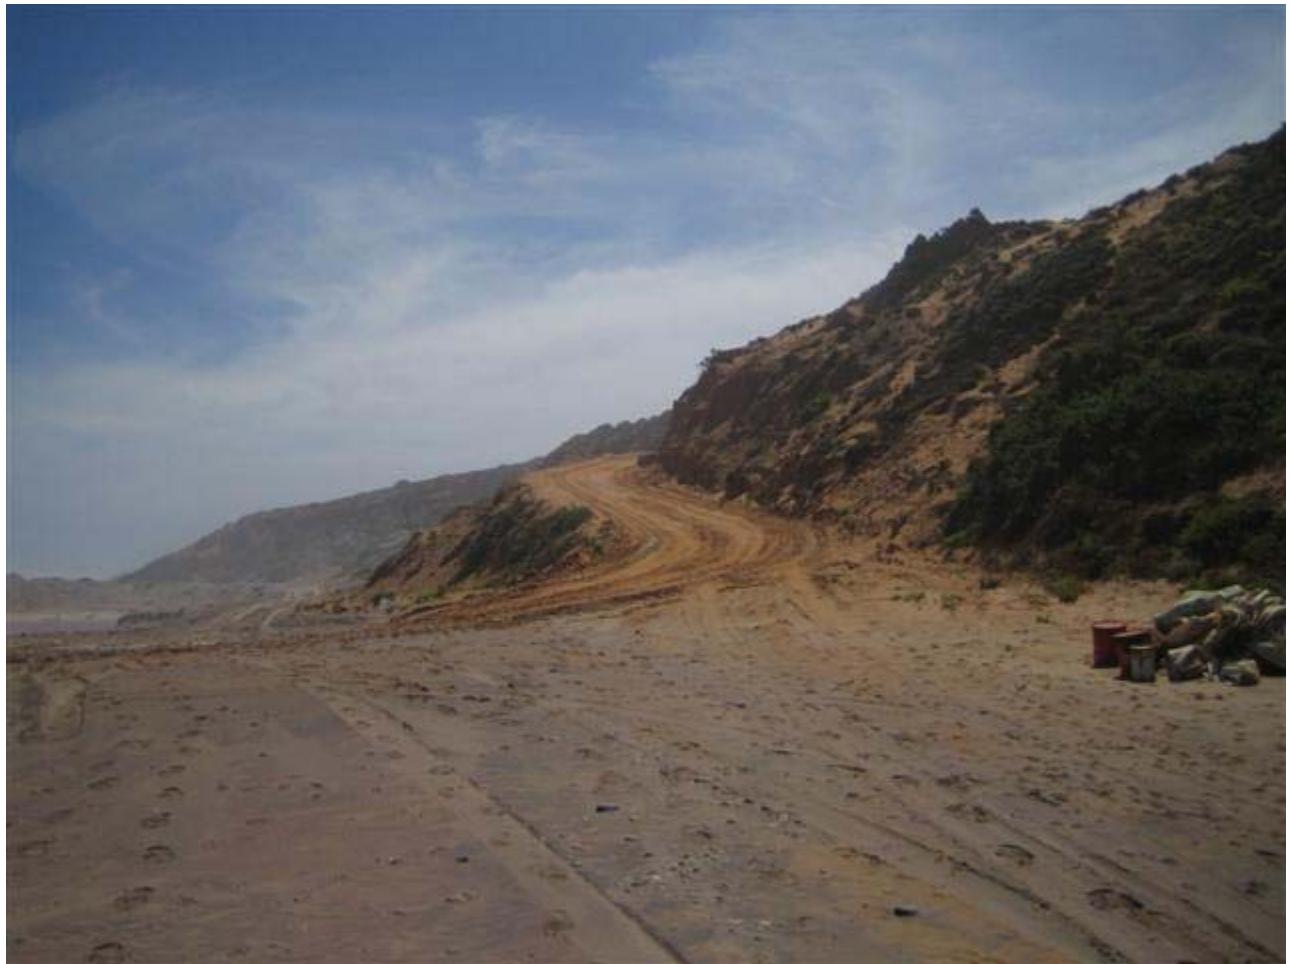
**PLATE 25 – P47**

**Well maintained beach access road**

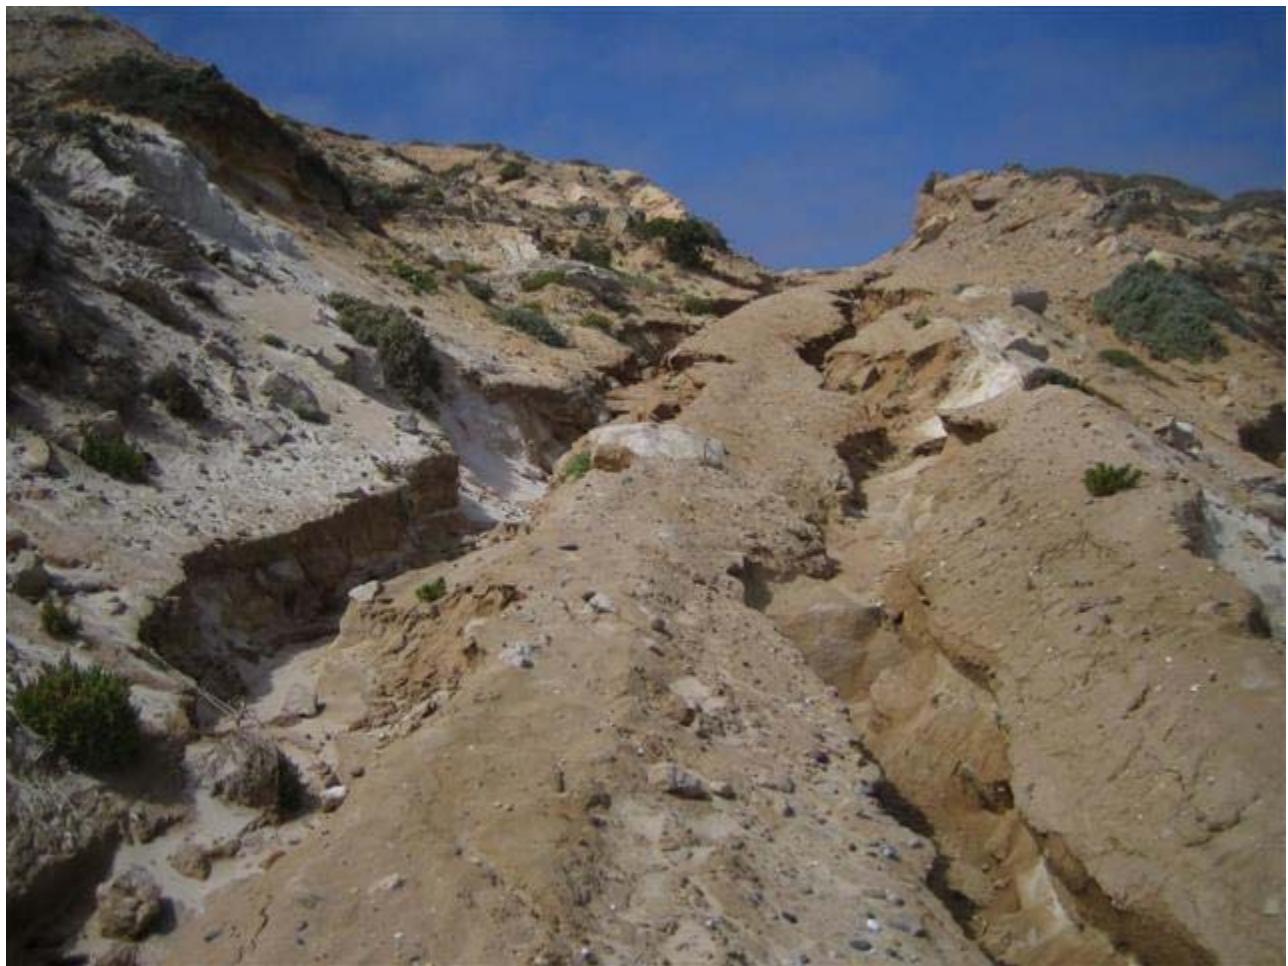
**PLATE 24 – P124**

**Severe erosion of former access road by stormwater runoff**

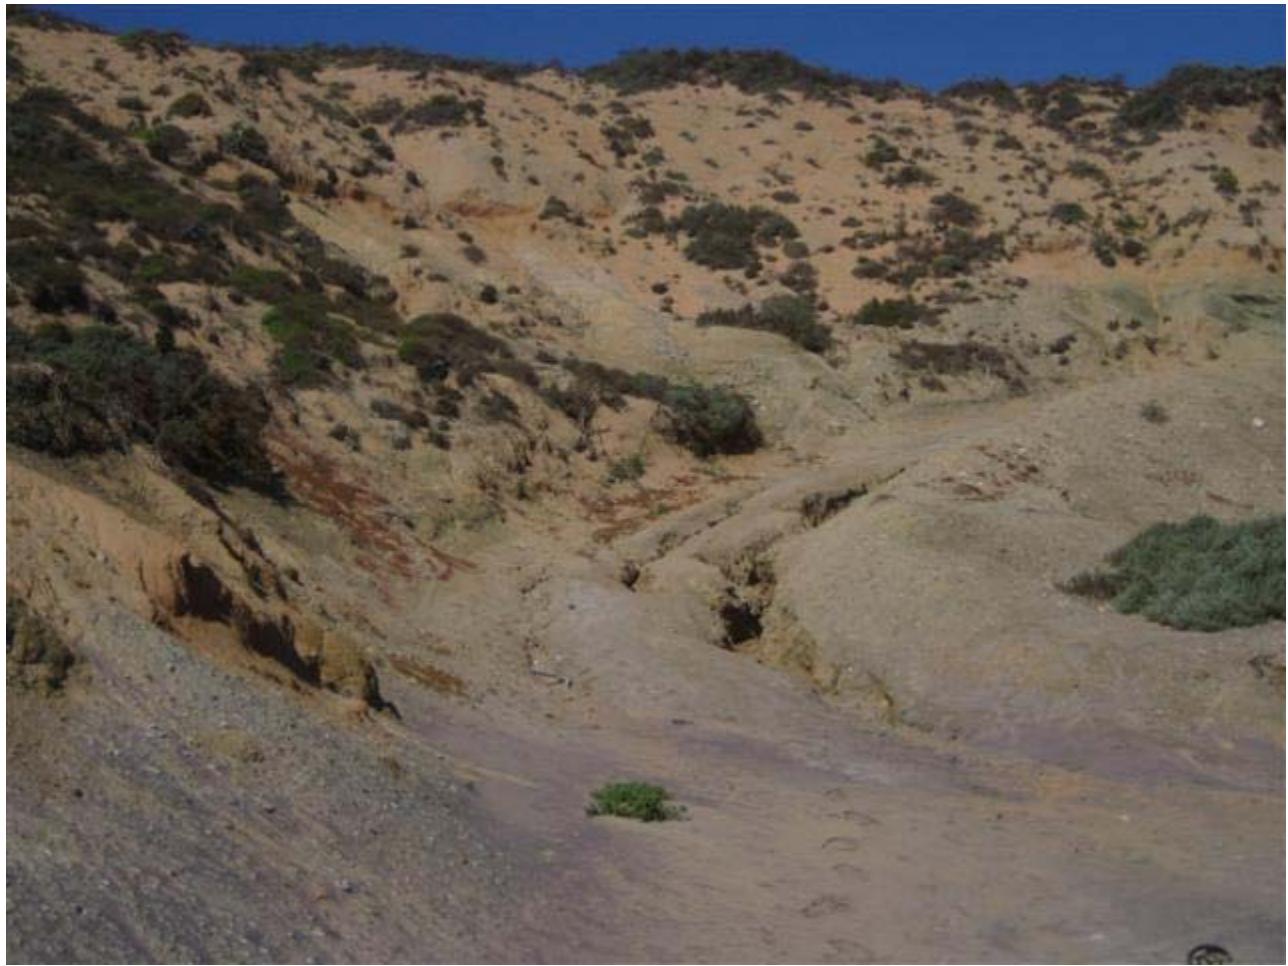
**PLATE 23 – P84**

**Erosion of disused road access by stormwater runoff**

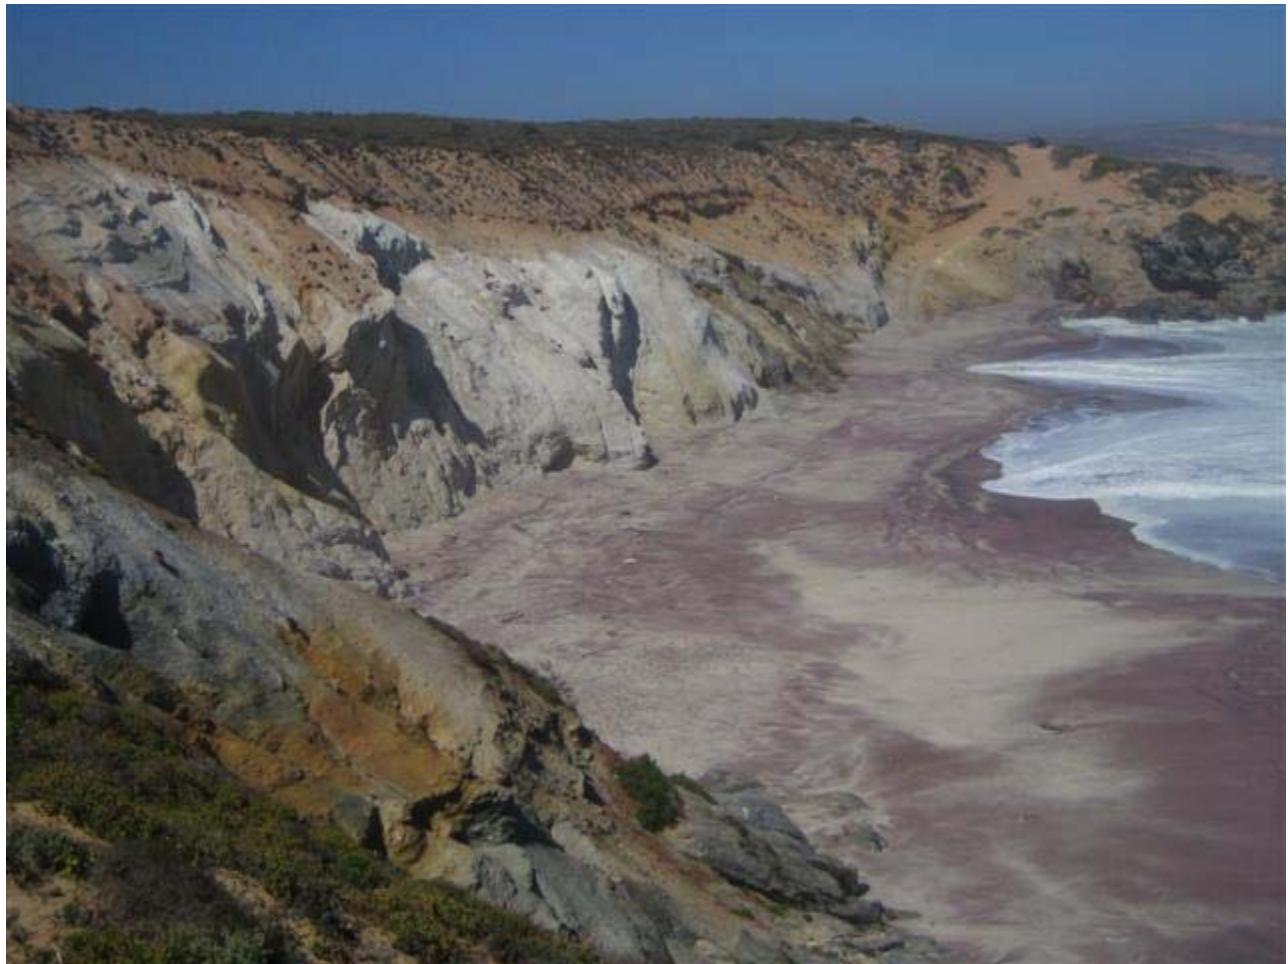
**PLATE 22 – P61**

Where the bases of the slopes comprise cemented light grey or white sands and gravels or dark brown and grey or dusky brown highly weathered rocks of the Gariep Formation, the erosion of these cohesive materials by storm surf is muted and undercutting at the base proceeds very gradually. Consequently, the slopes in these latter materials generally exhibit slopes varying between 45 degrees and subvertical. *PLATE 22 (P61)*

**Steep slopes evident down to the upper beach zone in both cemented light grey sands and gravels and weathered Gariep Fm. rocks. (LUTZ BAY)**

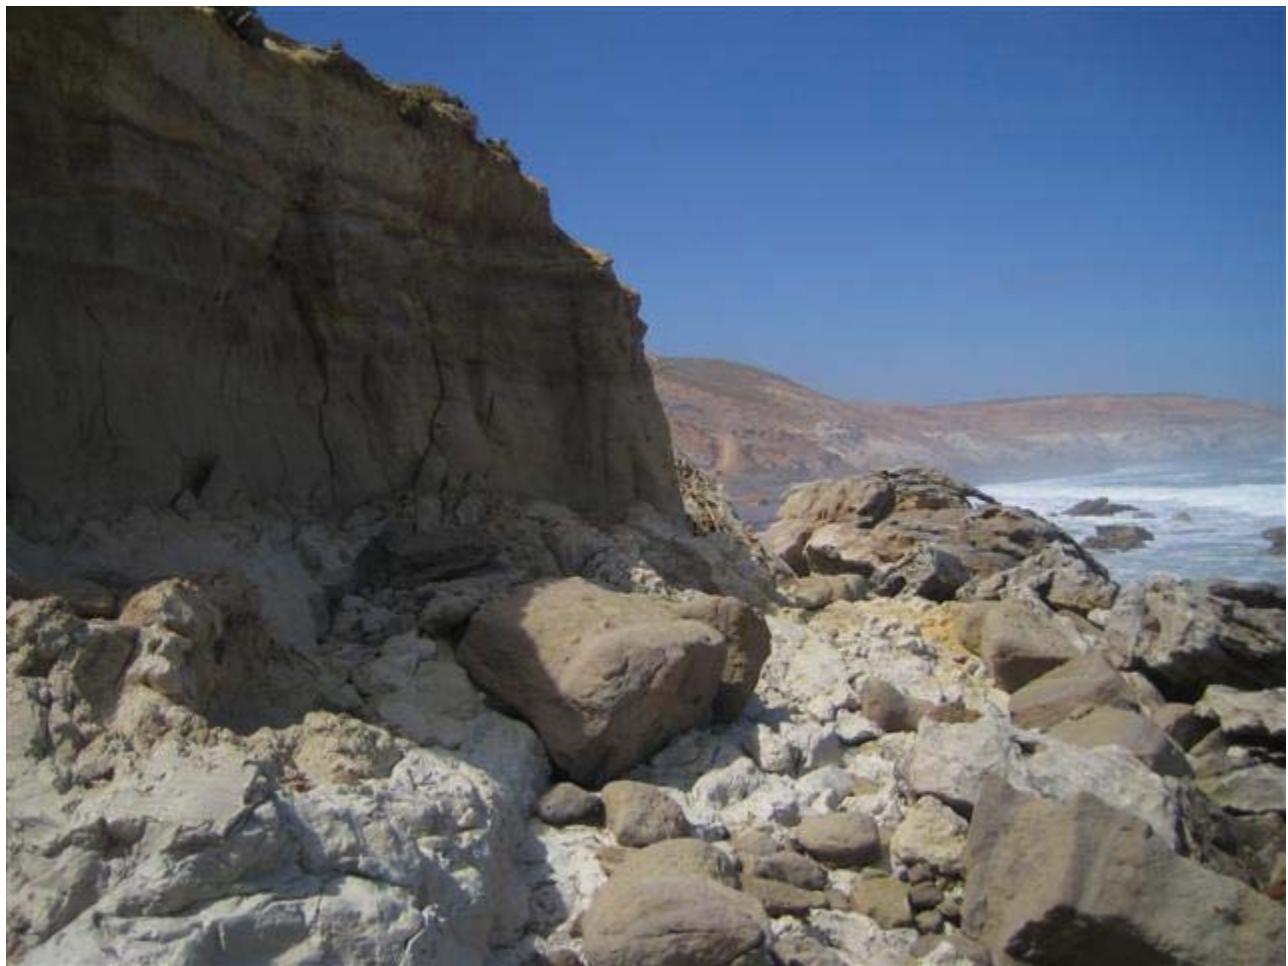
**PLATE 21 – P128**

**A point on the coastline comprising cemented light grey sands and gravels that has been saturated and eroded by sea action to cause failure of the slope**

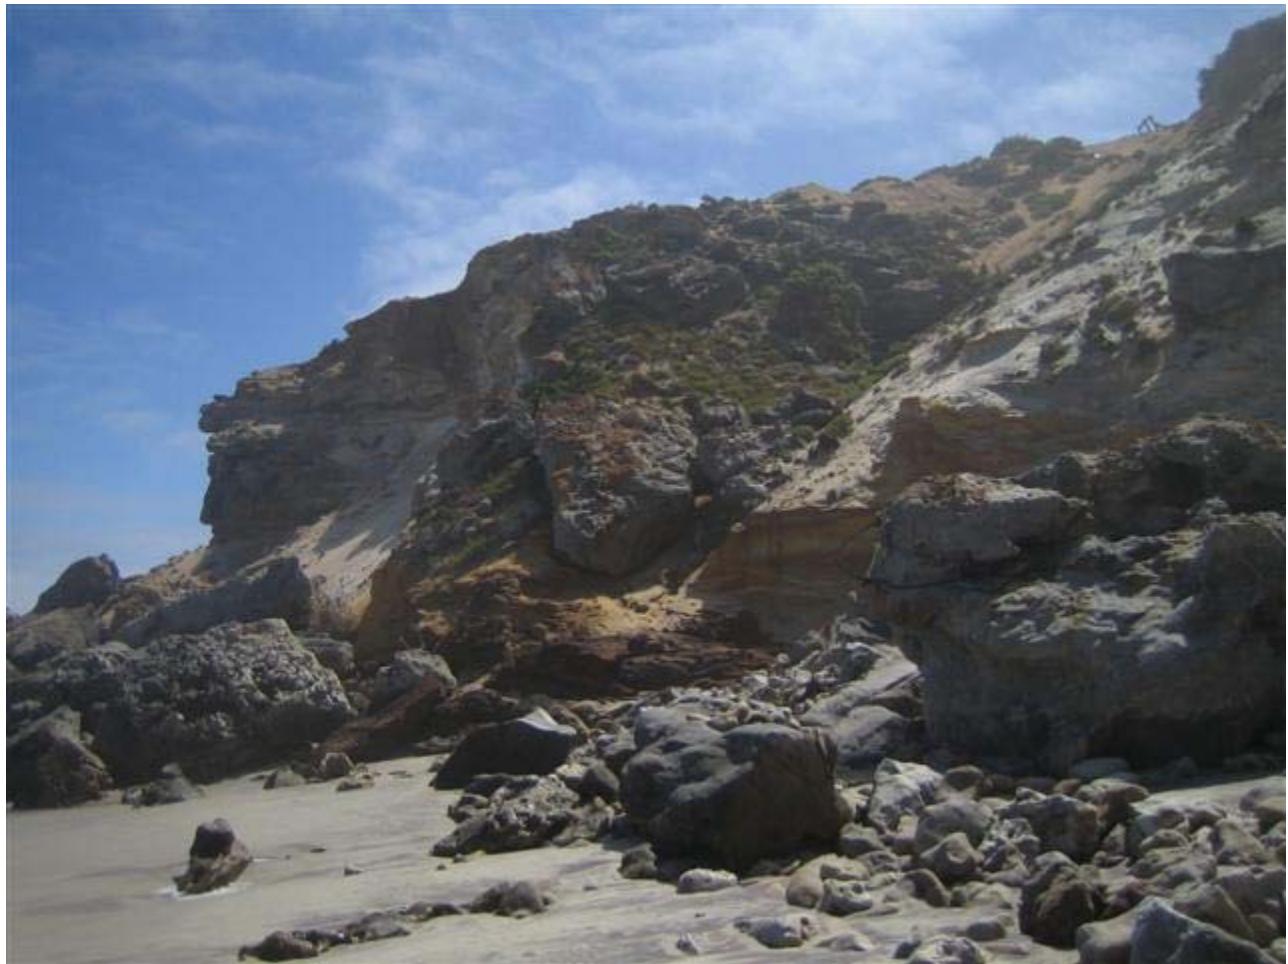
**PLATE 20 – P125**

**Interlayered silcretes, cemented light grey sands and gravels showing undercutting by the action of the sea with subsequent slope failure**

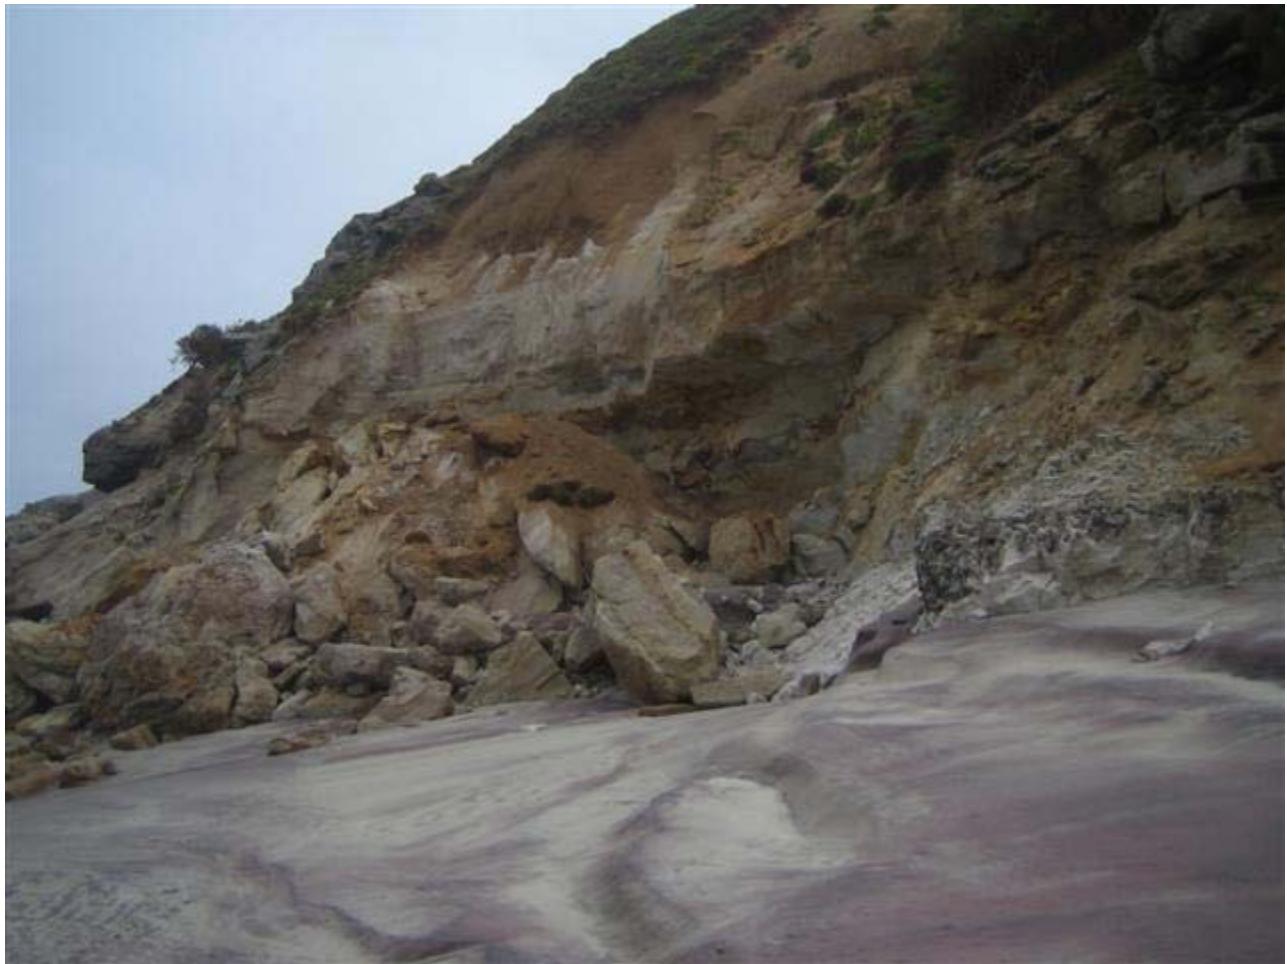
**PLATE 19 – P113**

**Undercutting at base of cemented light grey sands and gravels with Interlayered silcretes. Since these cemented materials form a point on the coastline they have obviously been subject to considerable battering by the sea resulting in undercutting and subsequent failure of the overlying materials**

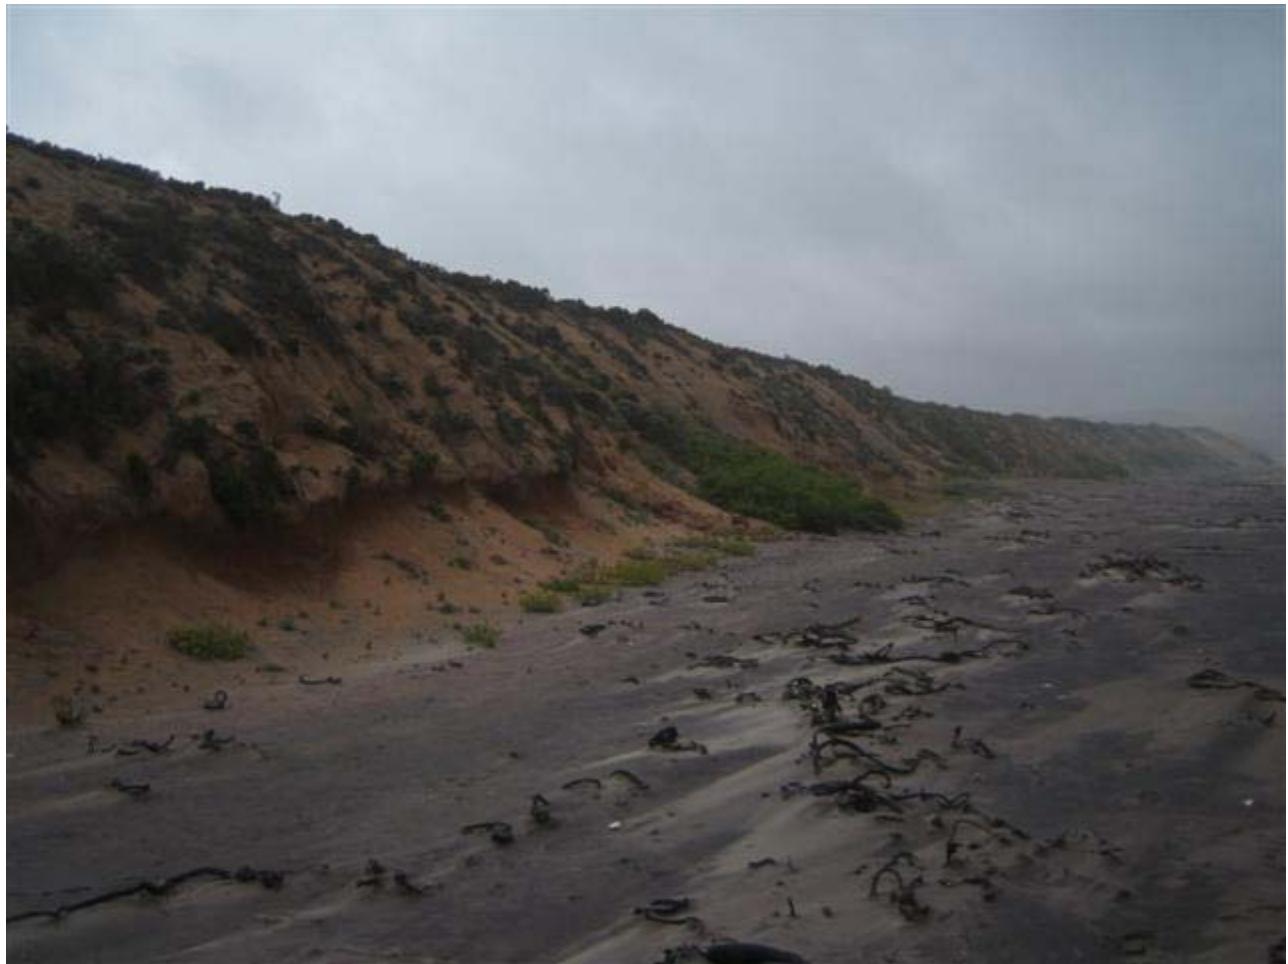
**PLATE 18 – P90**

**Base of slope in cemented reddish orange clayey sands and sandy clays showing evidence of undercutting and probable reduction in negative porewater pressures strength with saturation**

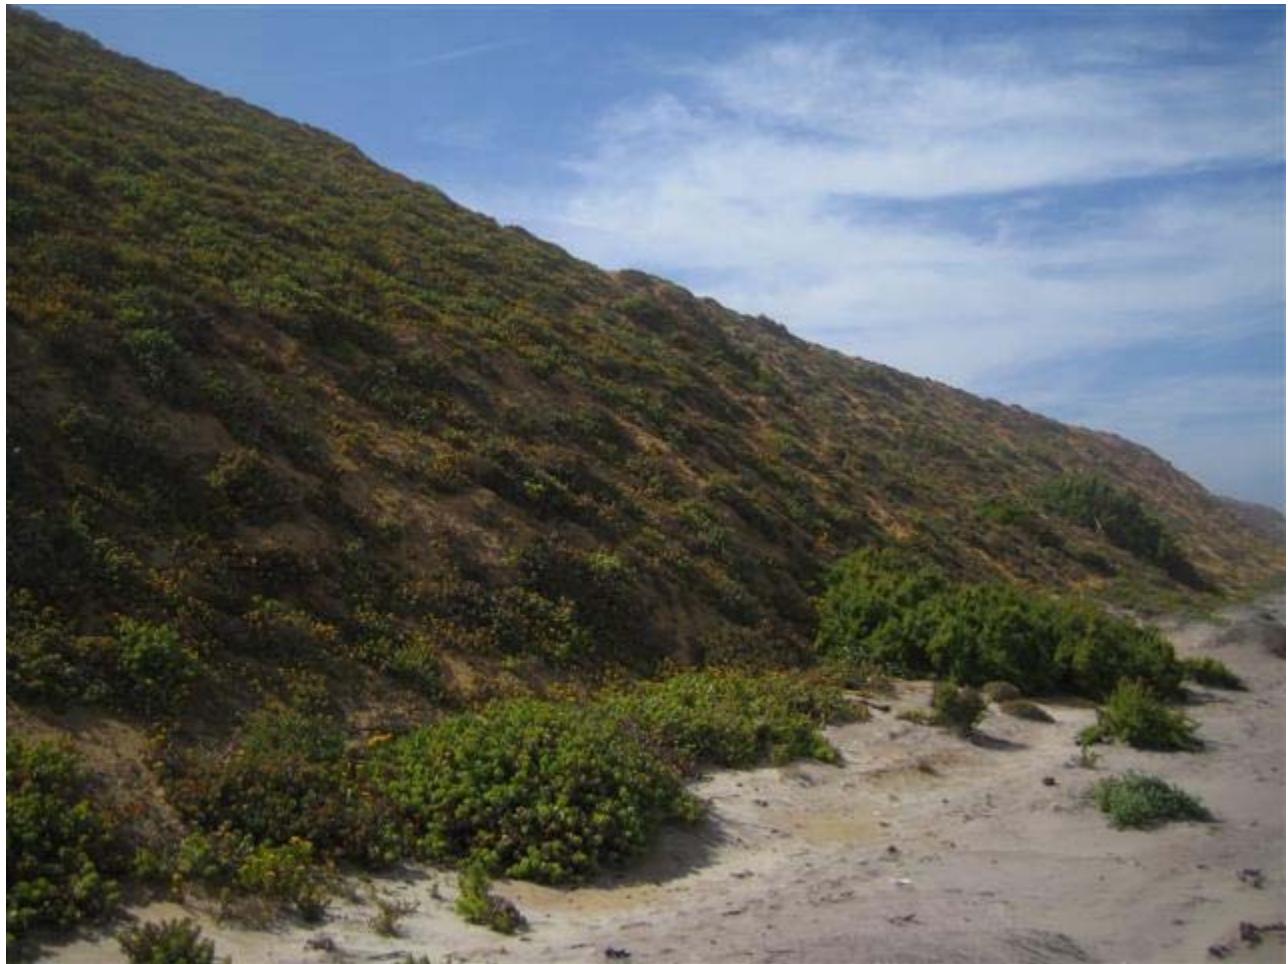
**PLATE 17 – P20**

**Sparsely vegetated and relatively steeper lower slope  
revealing prior undercutting of the base of the slope**

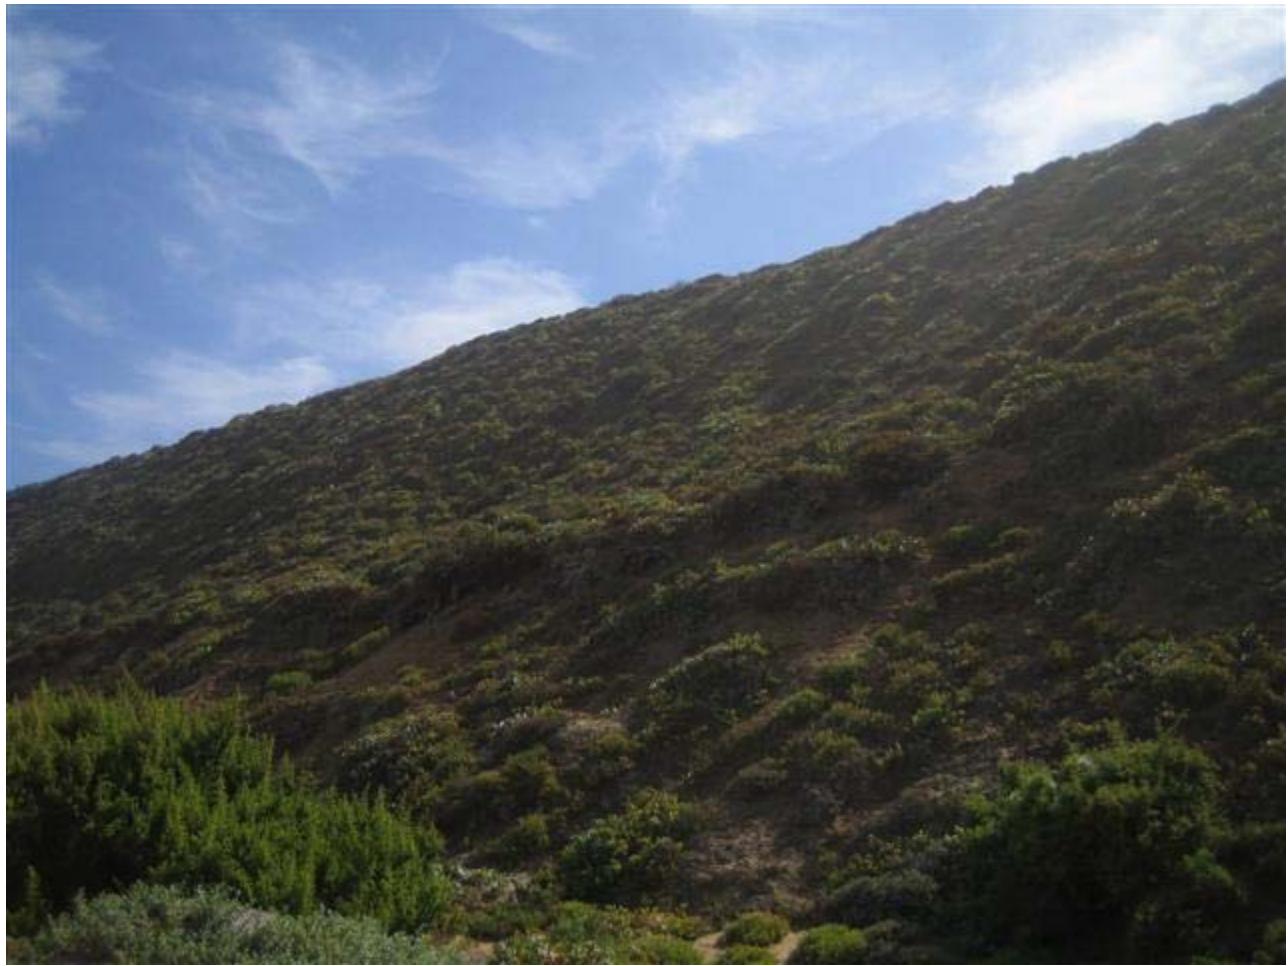
**PLATE 16 – P14**

**Localized slope failure initiated by earlier undercutting of  
the base of the slope**

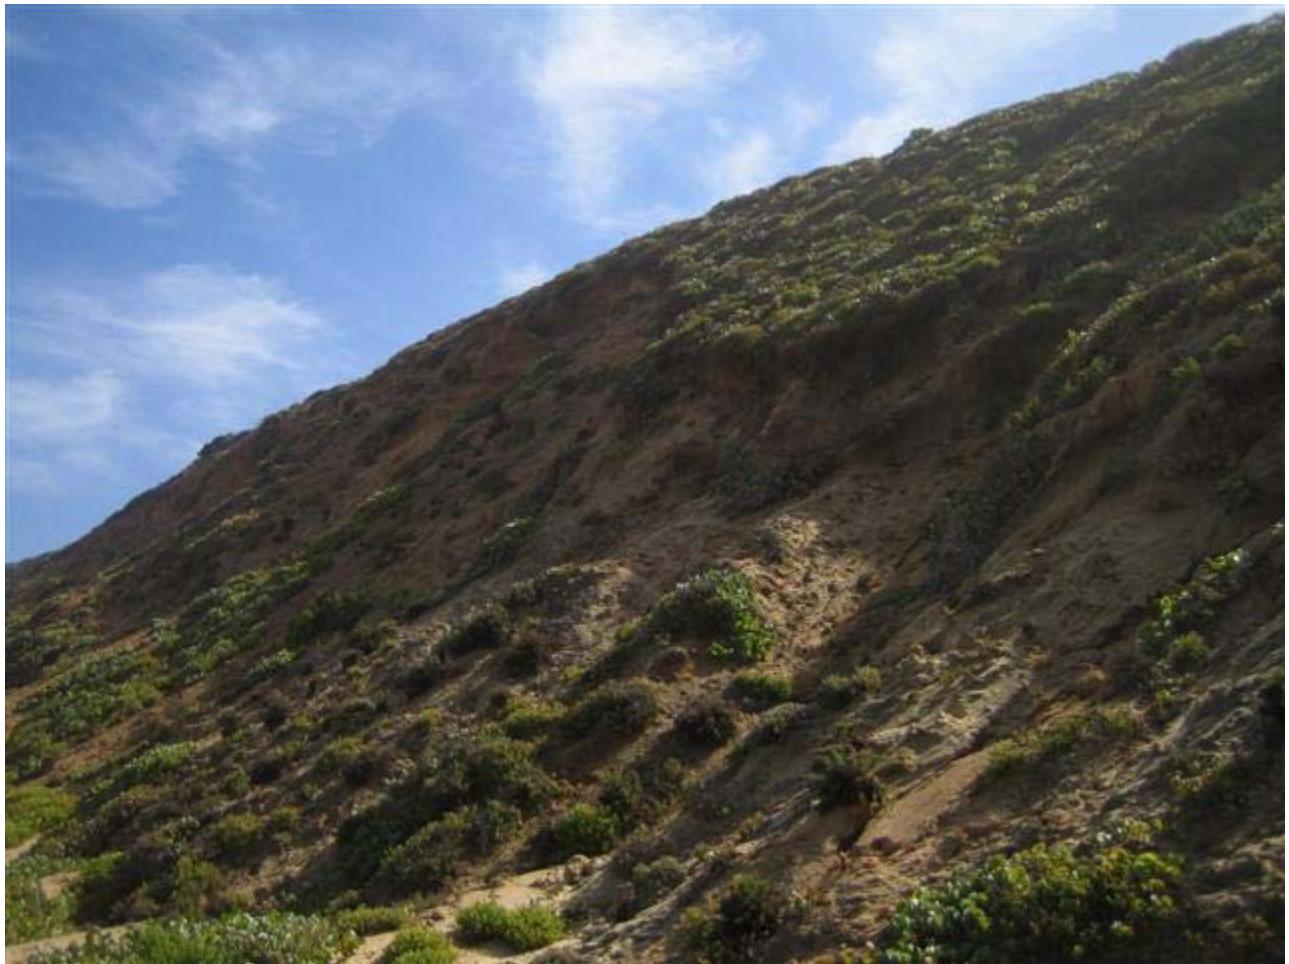
**PLATE 15 – P12**

**Slope failure across lower portion of slope initiated by undercutting of the base of the slope**

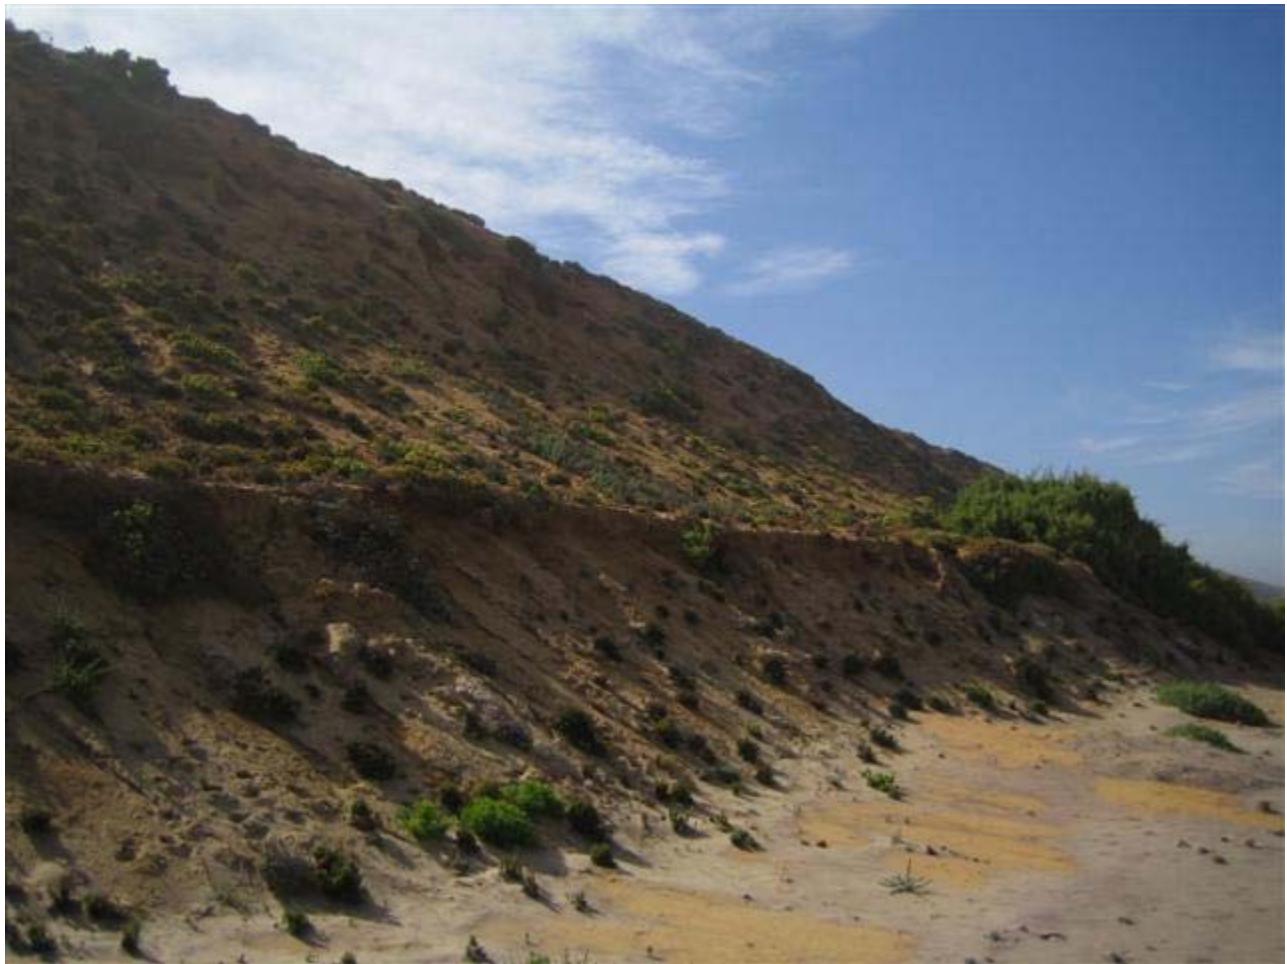
**PLATE 14 – P11**

**Relatively steeper lower slope indicates undercutting by stormsurf**

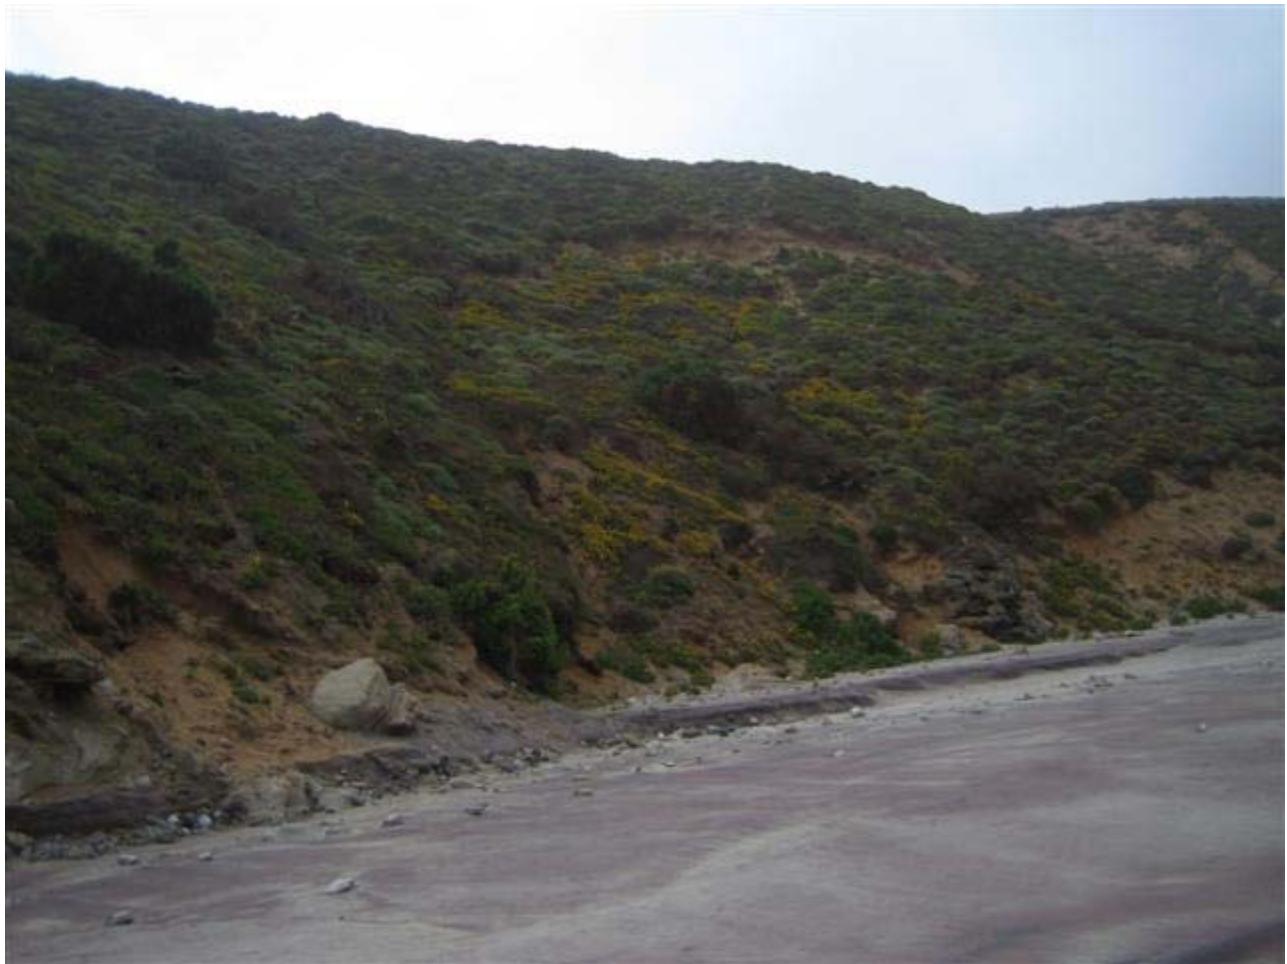
**PLATE 13 – P114**

On the basis of a number of relict arcuate slope failures visible in the sea-facing slopes *PLATE 11 (P10), PLATE 12 (P15) AND PLATE 13 (P114)* and widespread evidence of undercutting of the upper portion of the beach profile and the bases of the sea-facing slopes, it is evident that marine erosion is the factor primarily responsible for destabilizing sea-facing slopes and cliff faces. *PLATE 14 (P11), PLATE 15 (P12), PLATE 16 (P14), PLATE 17 (P20), PLATE 18 (P90), PLATE 19 (P113), PLATE 20 (P125) PLATE 21 (P128)* It is to be anticipated that substantial sediment movement will take place during extreme storm events, with partial or

**Arcuate scarp visible on the mid-slope as a result of undercutting at the base of the slope**

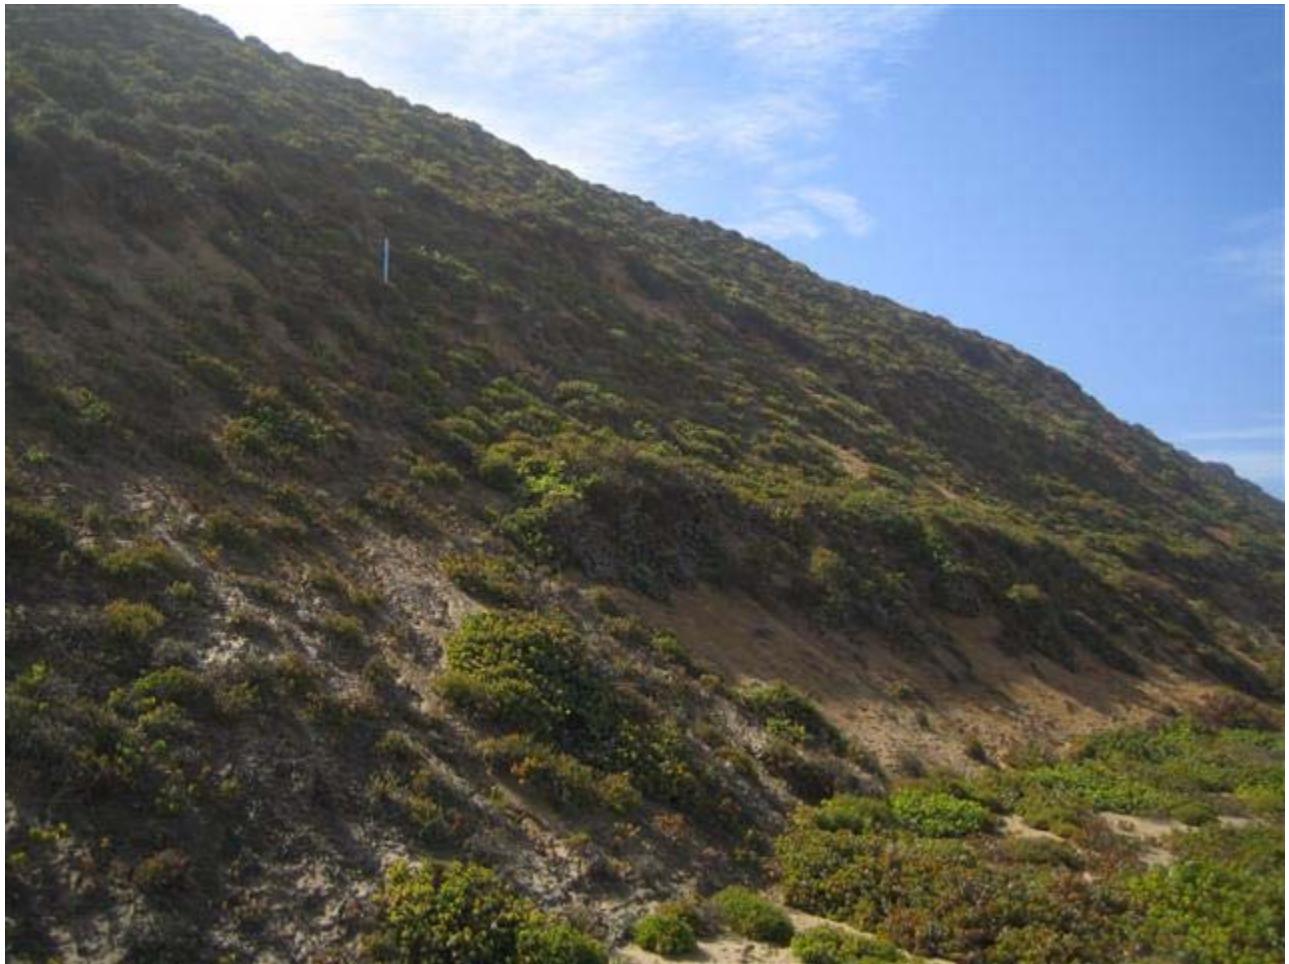
**PLATE 12 – P15**

**Two phases of slope failure visible at this location in reddish orange sands. The backscarp of the earlier failure occurs mid-way up the slope while the more recent failure is evident at the base of the slope**

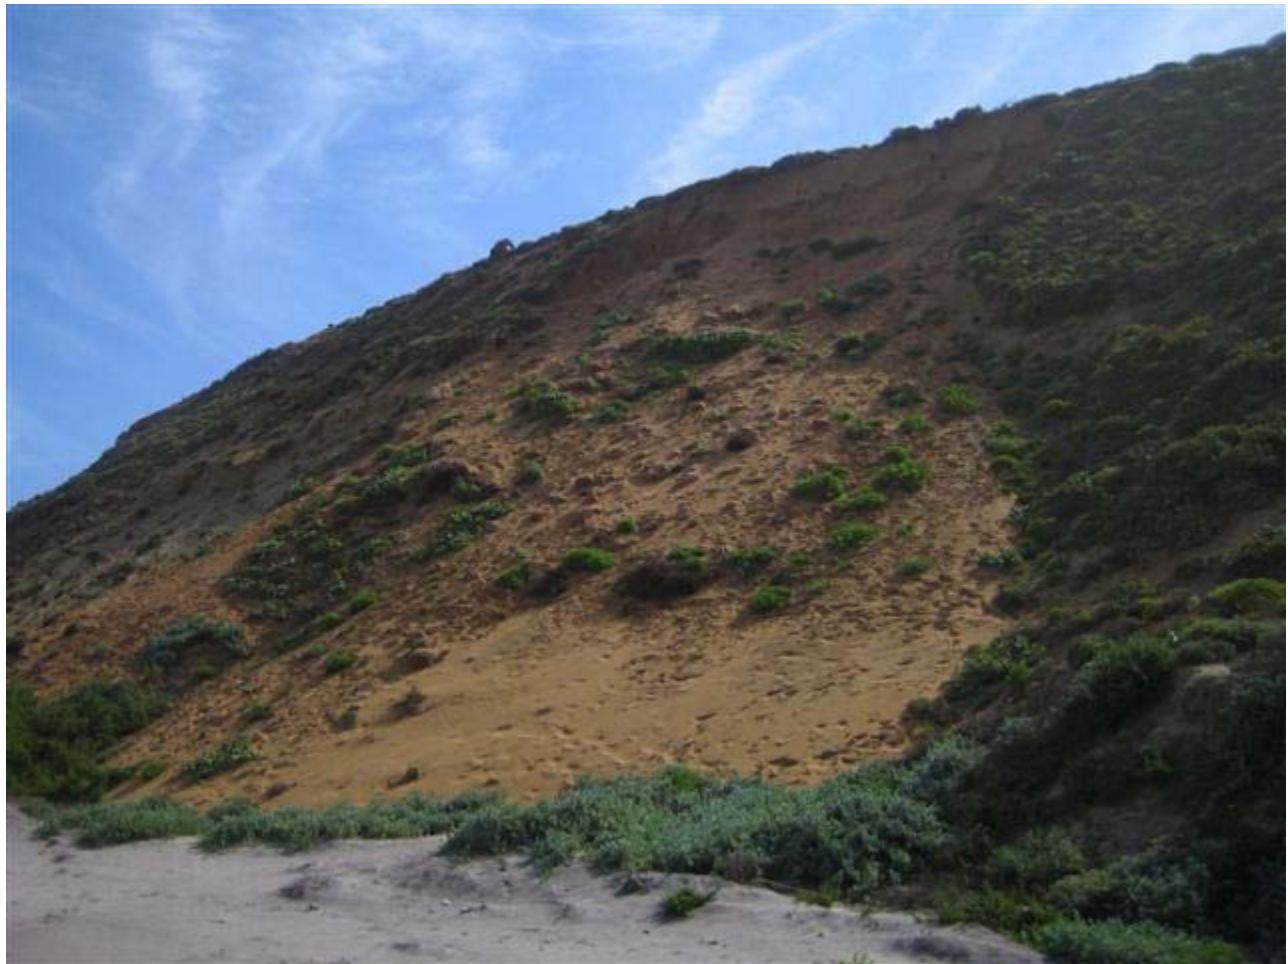
**PLATE 11 – P10**

**Slope failure precipitated by undermining of the base of the slope by the sea in reddish orange sands**

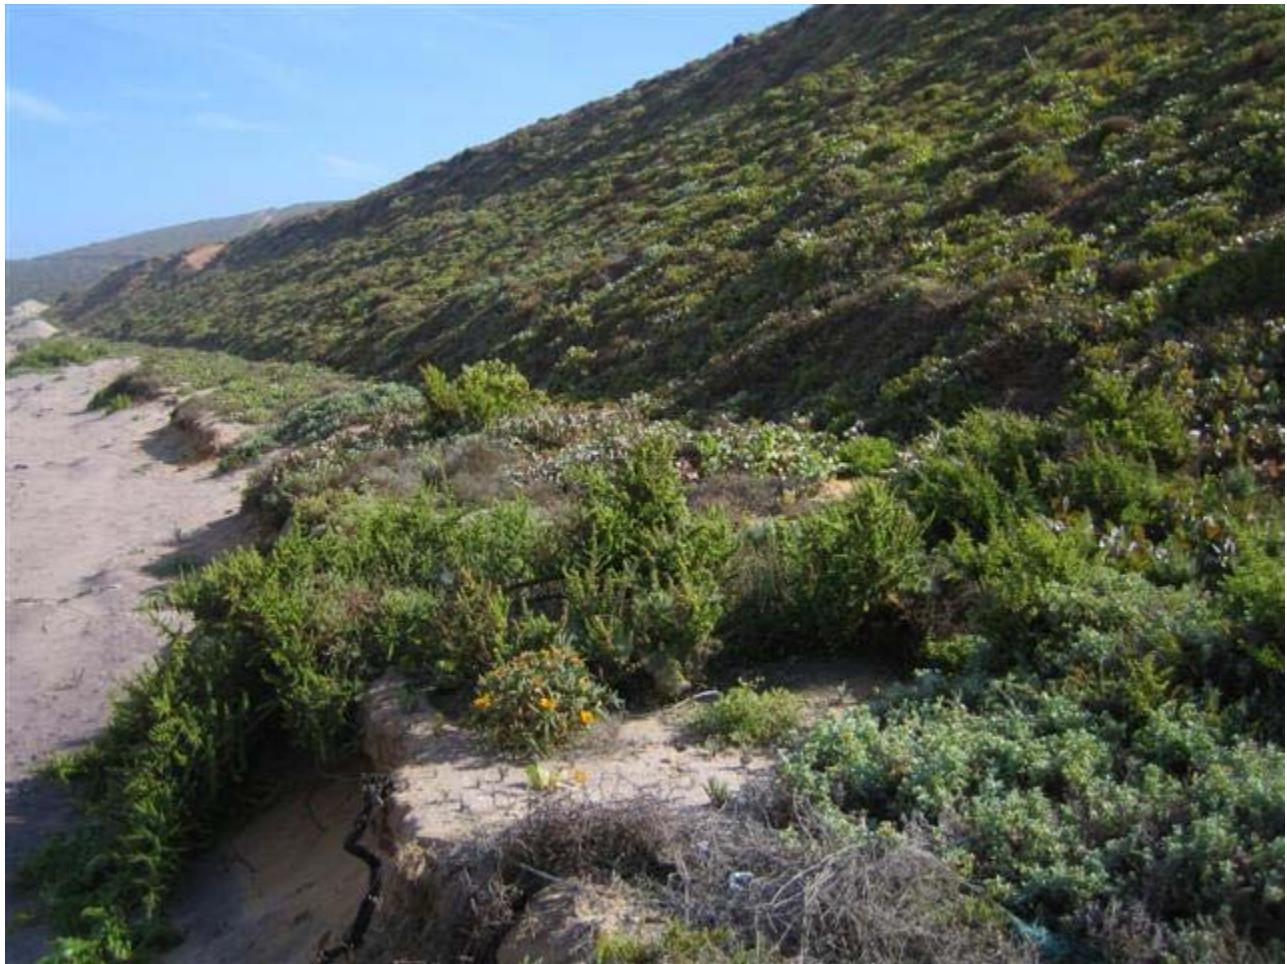
**PLATE 10 – P4**

The well vegetated slopes are less susceptible to wind and water erosion and often correlate with stable slopes in a particular geological setting as would be anticipated. *PLATE 10 (P4) refers*

**Reddish soil slope with base well defined by intersection of  
revegetated raised beach deposit at base**
