**REPORT TO  
GCS (PTY) LTD ON A PRELIMINARY  
GEOTECHNICAL ASSESSMENT OF  
SEAFACING SLOPE AND CLIFF  
FACE STABILITY DURING  
BEACH MINING OPERATIONS,  
TORMIN MINERAL SANDS PROJECT,  
WEST COAST, RSA**

**Reference**  
3102

**Date**  
October 2006

**DAVIES  
LYNN &  
PARTNERS**  
(PROPRIETARY) LIMITED

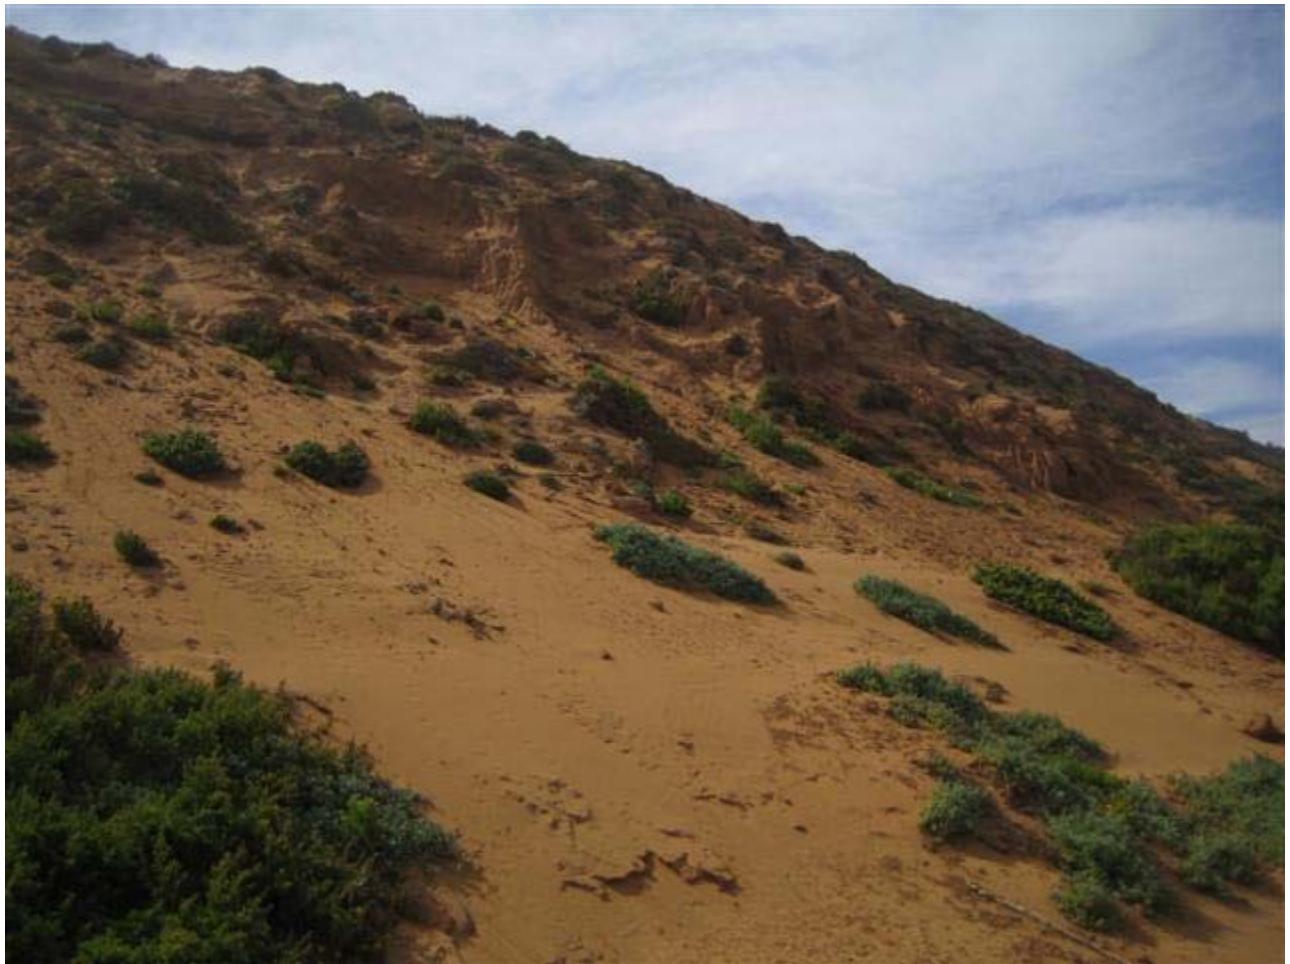
**PLATE 9 – P22**

The low rainfall and dry climate result in the soils possessing a low natural moisture content typically ranging between 6 and 10 per cent. This results in any soils possessing a significant clay content of approximately 20 per cent or greater becoming highly dessicated and stiff to hard in consistency. *PLATE 9 (P22) refers.*

**Dessication of clayey sands and sandy clays forming steep slopes – cemented reddish orange materials**

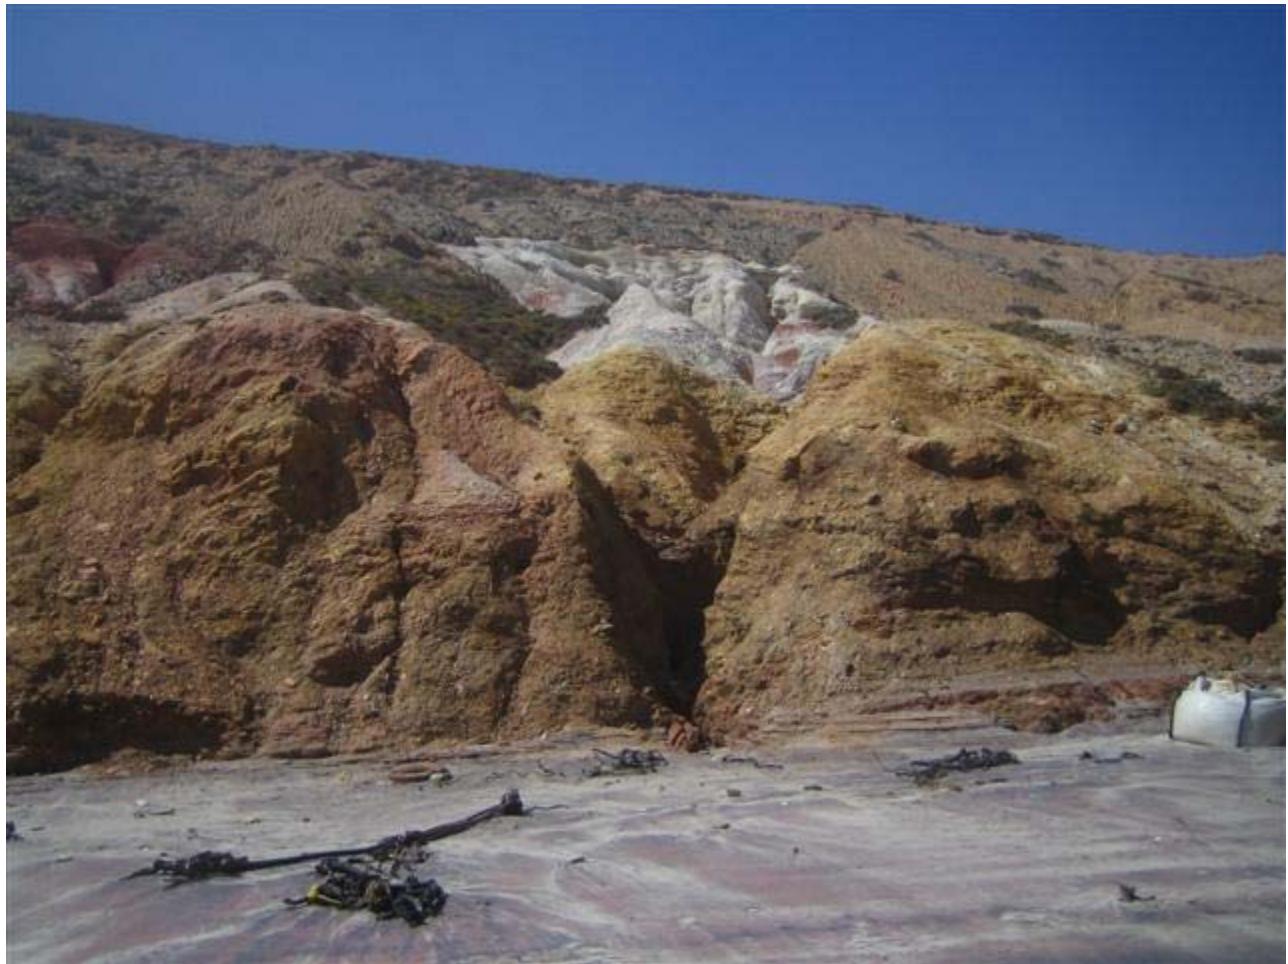
**PLATE 8 – P142**

stormwater runoff. This leads to preferential surface drainage courses and surface weathering. *PLATE 5 (P13), PLATE 6 (P79), PLATE 7 (P141) AND PLATE 8 (P142) refer.*

**Stormwater runoff erosion of weathered Gariep Formation  
overlain by cemented light grey sands and gravels**

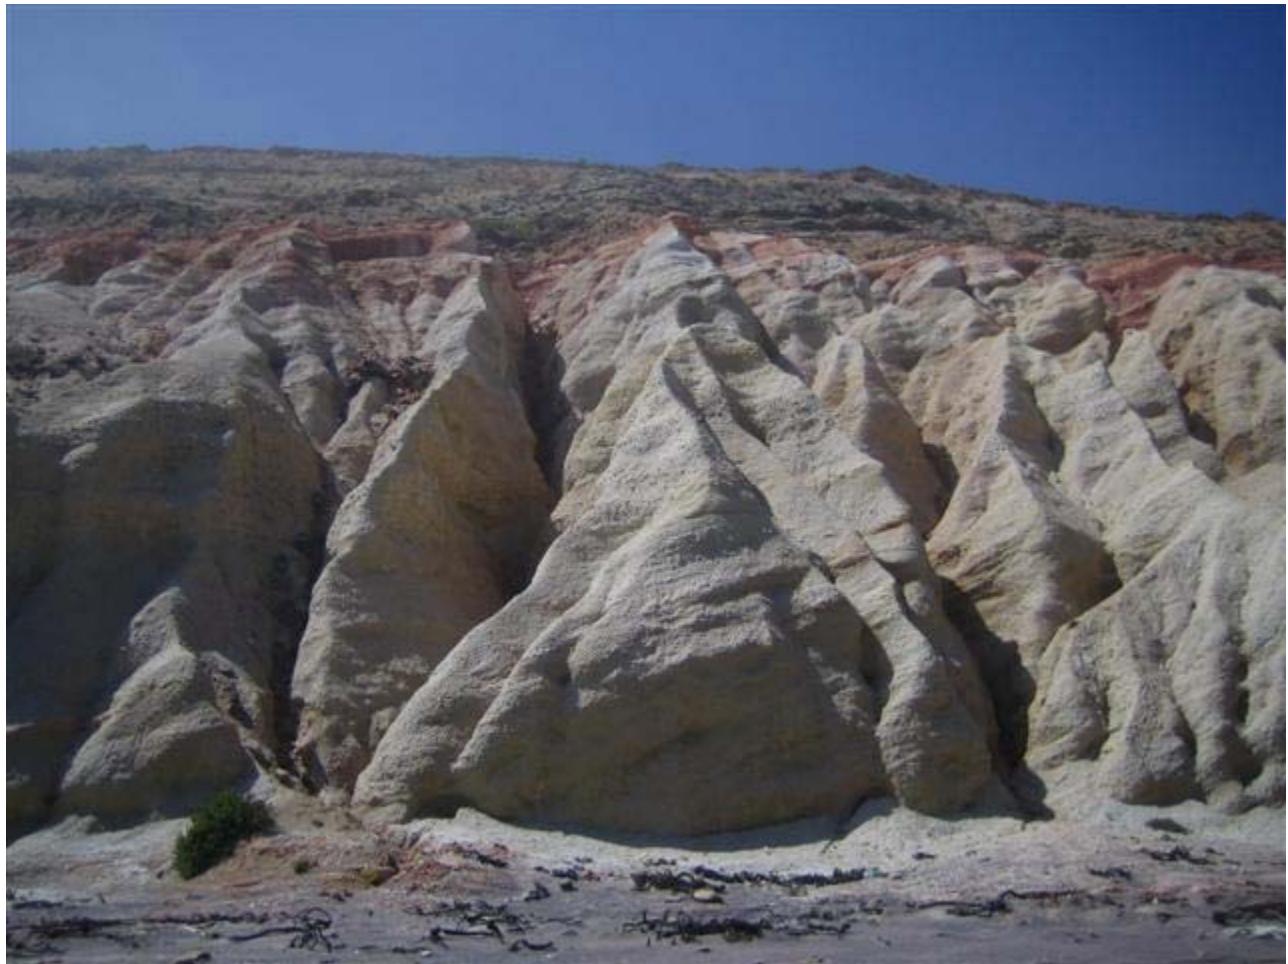
**PLATE 7 – P141**

**Stormwater runoff erosion of cemented light grey sands and gravels**

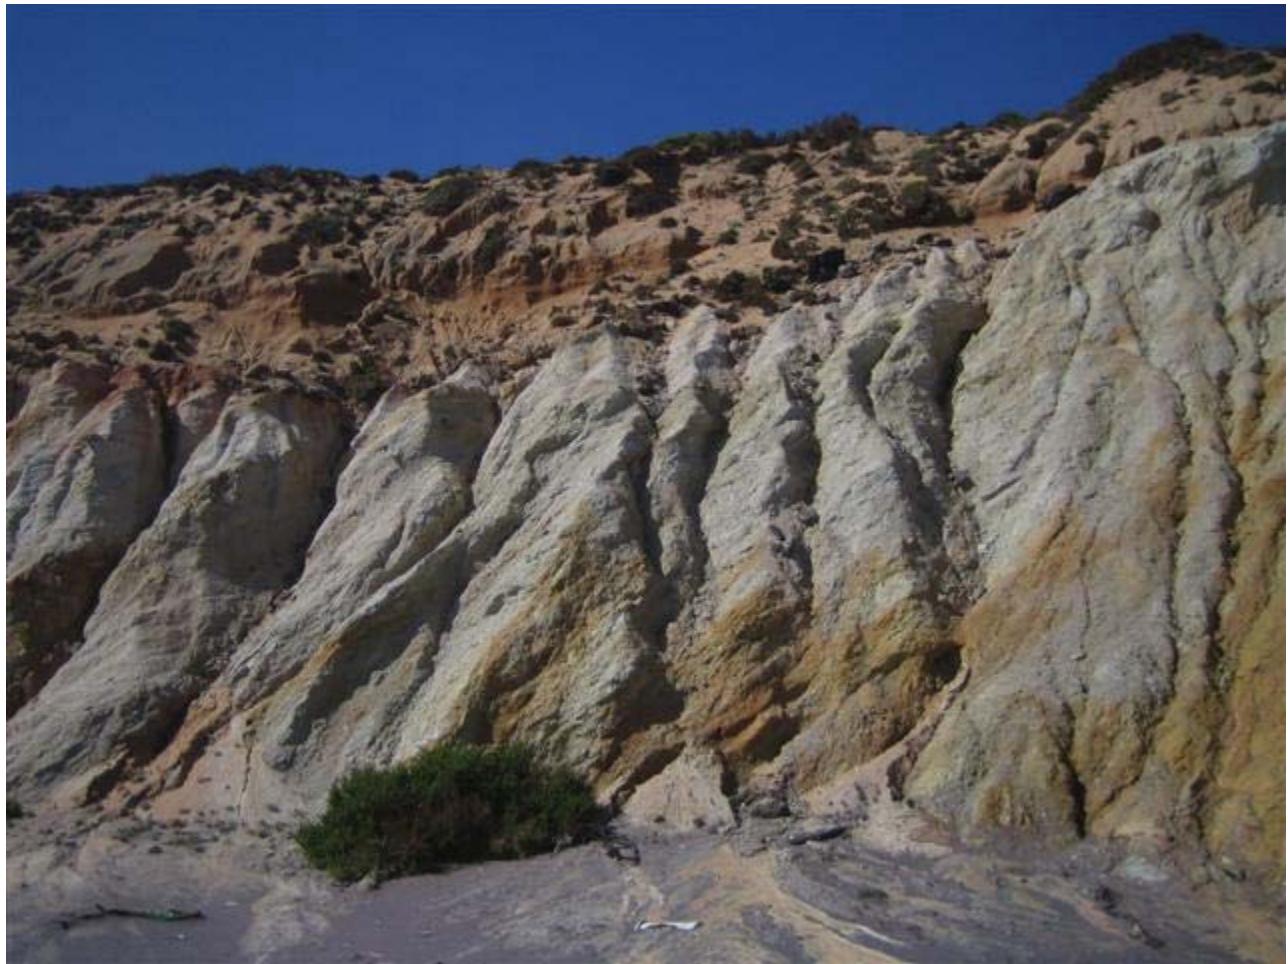
**PLATE 6 – P79**

**Stormwater runoff erosion of cemented light grey sands and gravels containing a clay matrix overlain by cemented reddish orange clayey sands and sandy clays**

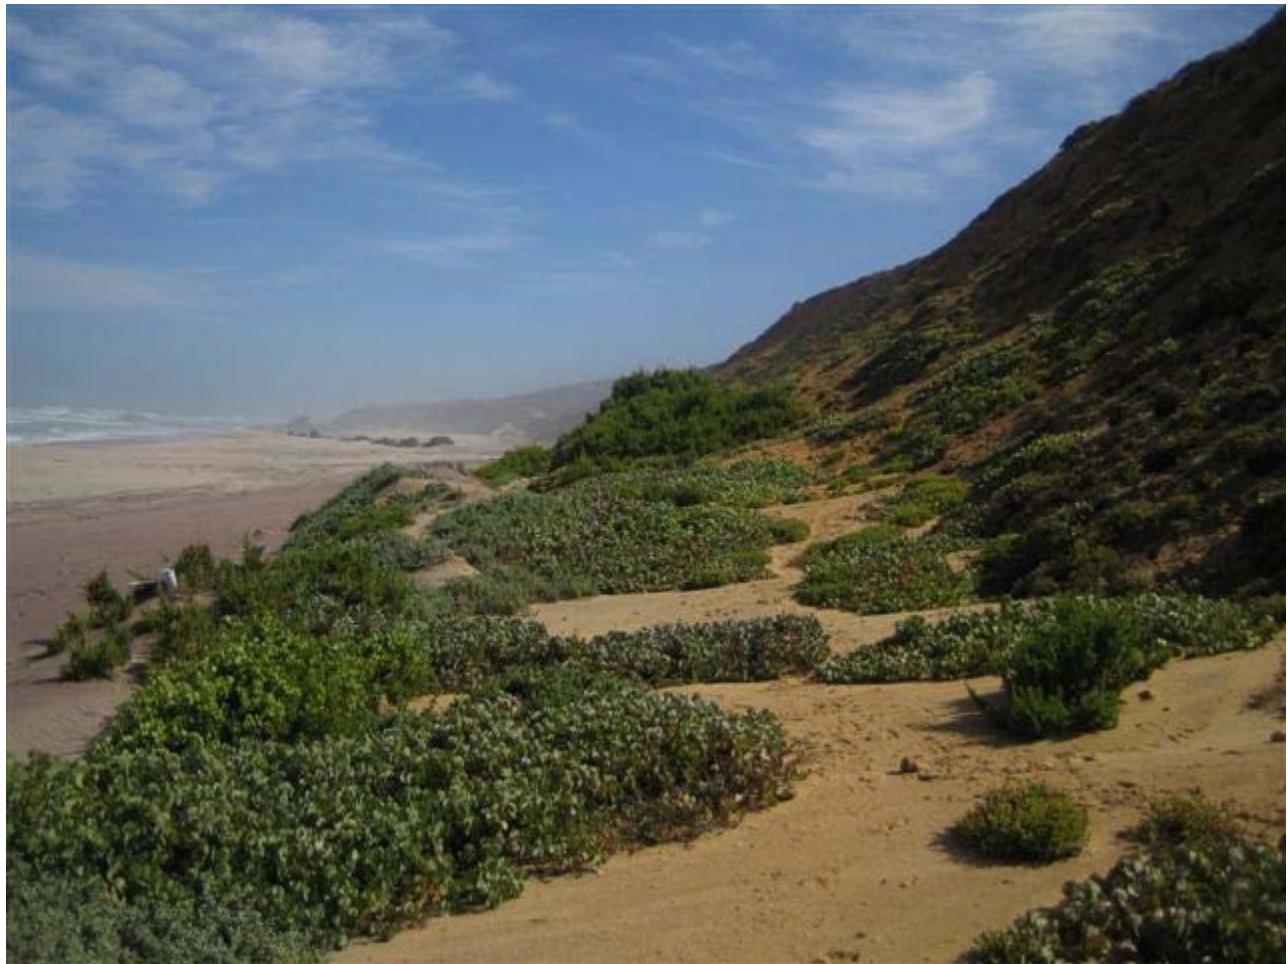
**PLATE 5 – P13**

**View northwards showing sparsely vegetated reddish orange sand slopes and deposit at toe of eroded and wind blown material**

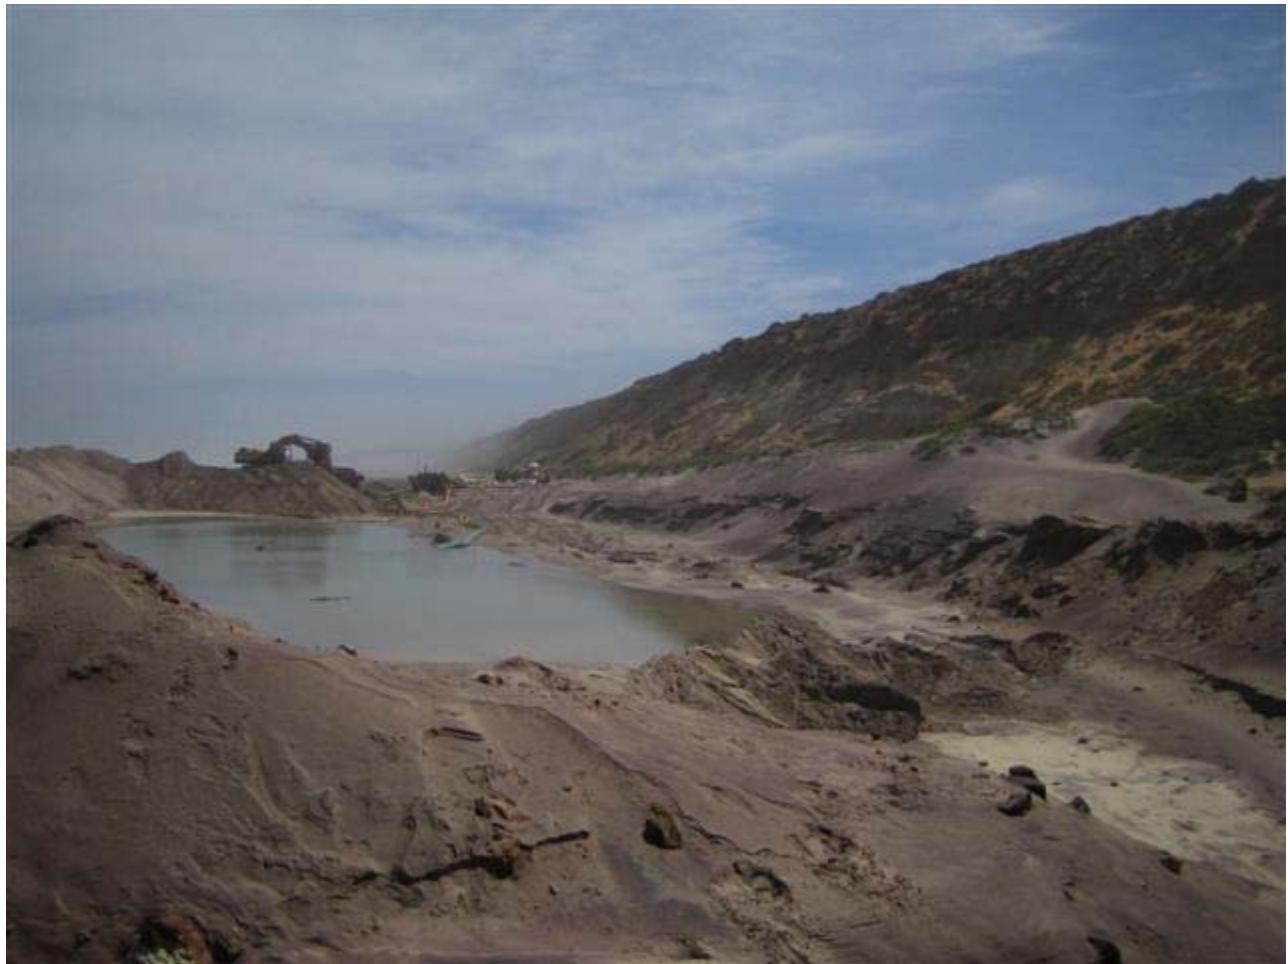
**PLATE 4 – P42**

The methodology adopted by the Trans Hex Group mining contractors has generally involved the construction of a 5 to 10m horizontal toe berm of approximately  $\leq 2\text{m}$  height at the bases of the existing sea-facing slopes. *PLATE 1 (P98)* Furthermore, a temporary barrier comprising boulders or slabs of rock is sometimes placed in the near-shore surf zone to dissipate wave energy *PLATE 2 (P99)* or alternatively a sand berm constructed between the surf zone and the excavation. *PLATE 3 (P41) AND PLATE 4 (P42)*

**Trans Hex Group diamond mining operations**  
**View northwards showing both slope toe protection berm**  
**and berm between surf-zone and excavation**

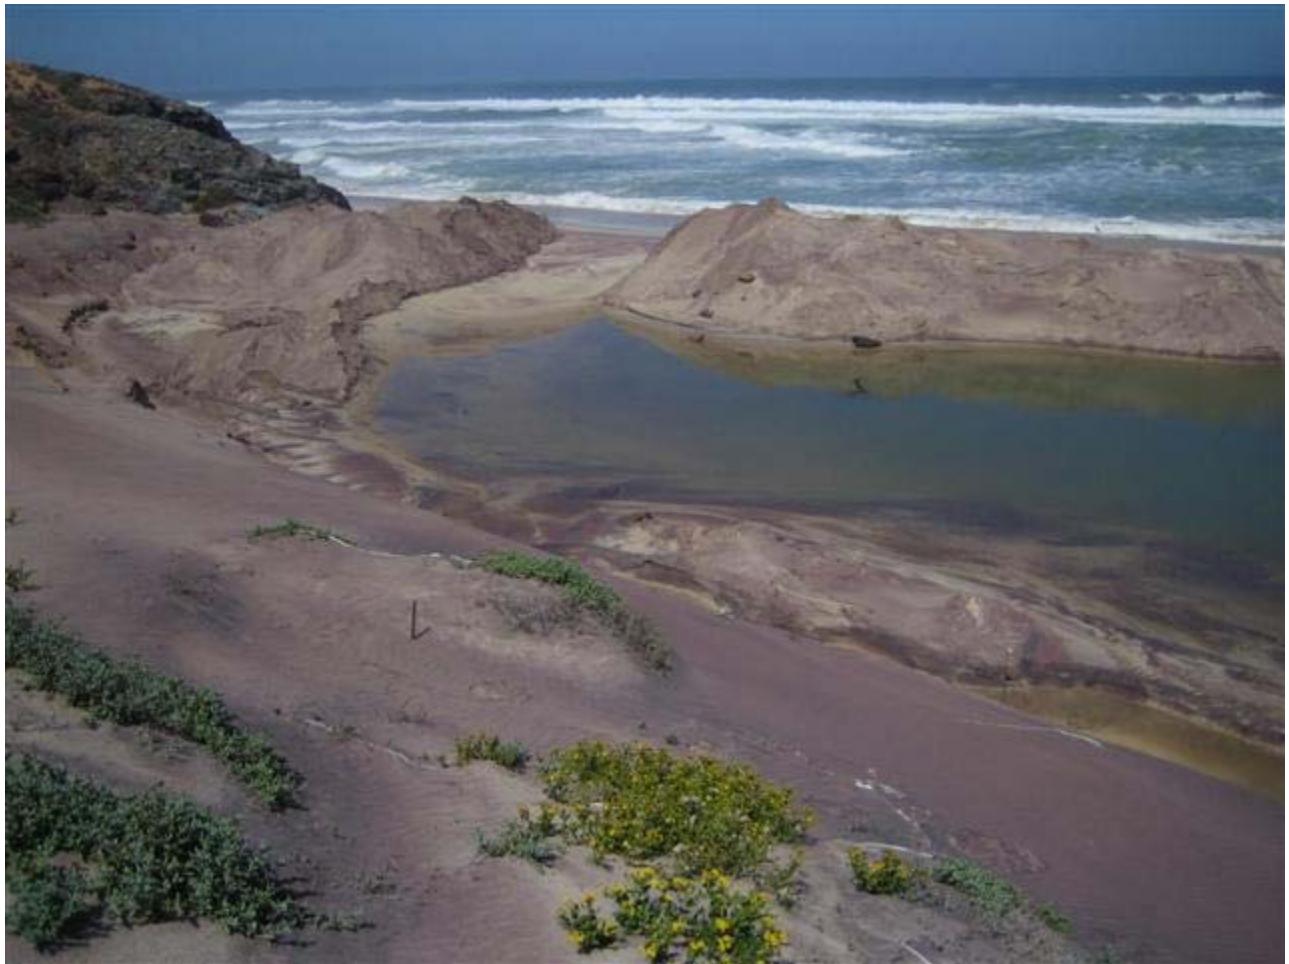
**PLATE 3 – P41**

**Trans Hex Group diamond mining operations**  
**View seawards showing a sand berm constructed between**  
**the surf-zone and the excavation**

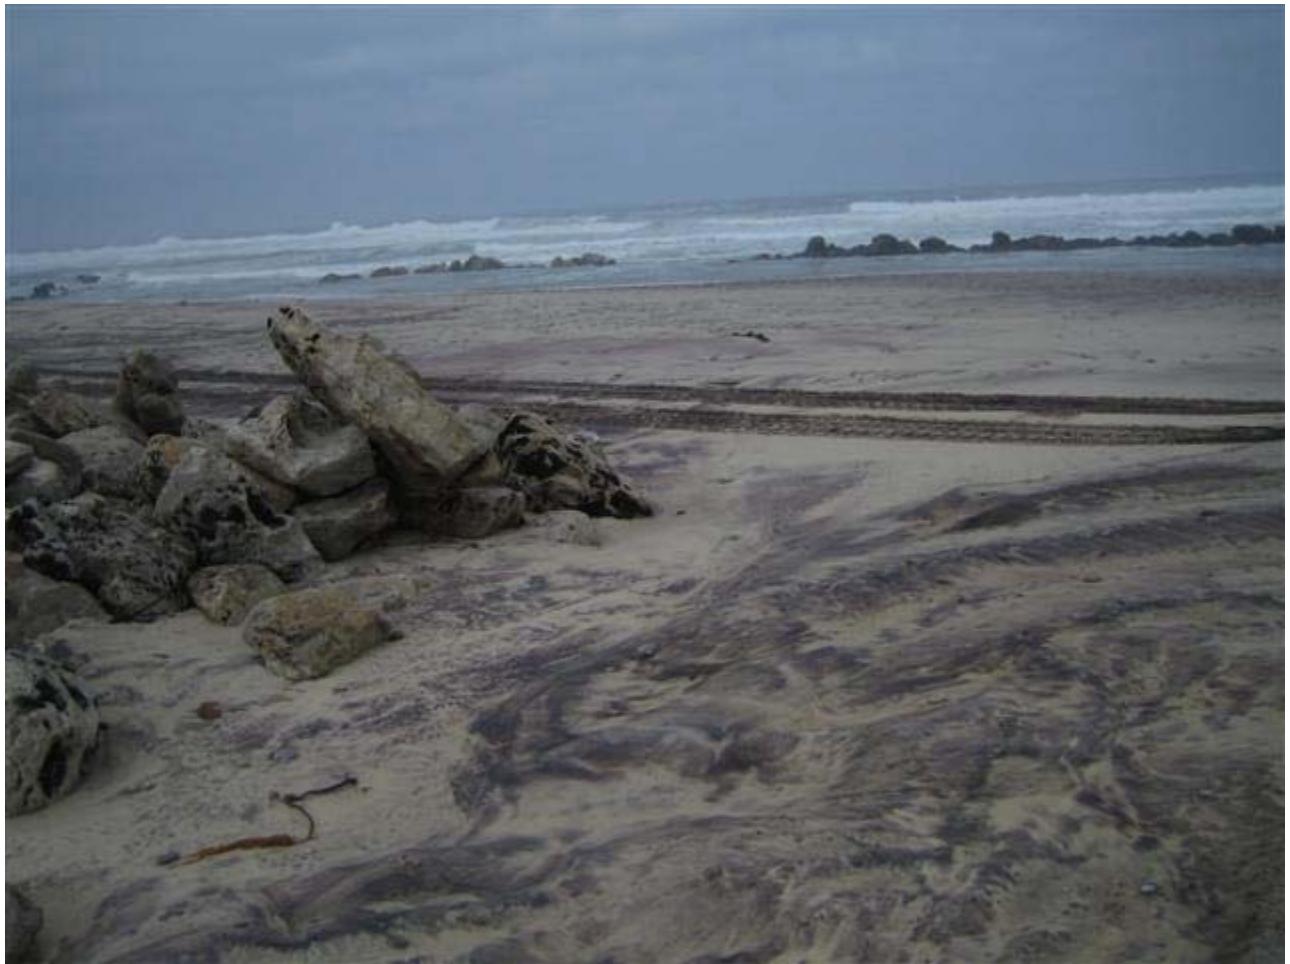
**PLATE 2 – P99**

**Trans Hex Group diamond mining operations**  
**View seawards showing a temporary barrier of boulders or**  
**slabs of rock placed in the near-shore surf zone to dissipate**  
**wave energy. Stockpile of rocks in the foreground**

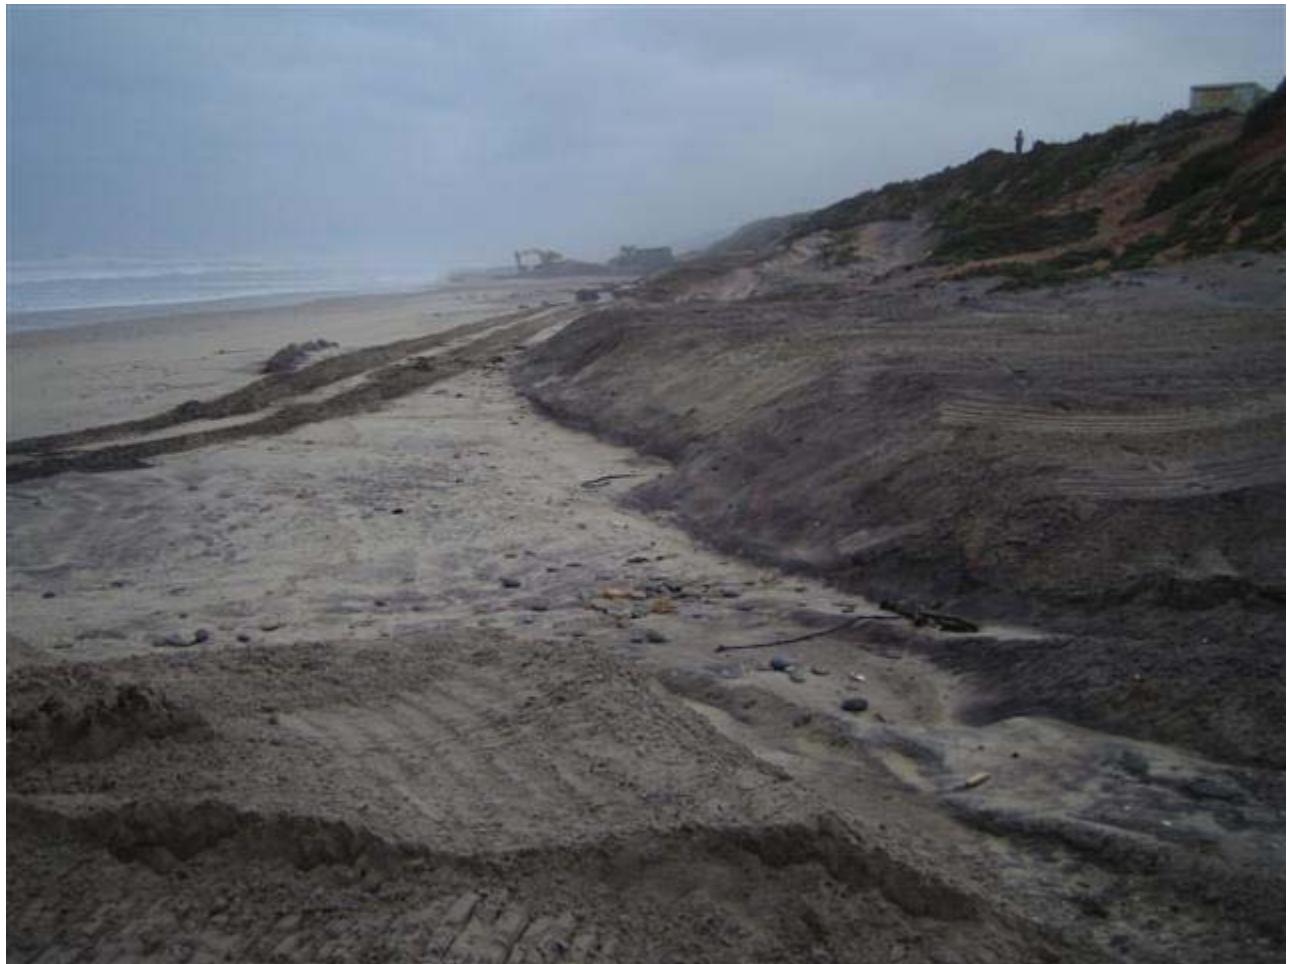
**PLATE 1 – P98**

**Trans Hex Group diamond mining operations**  
**View northwards showing the berm constructed on the**  
**upper beach to protect the sea-facing reddish orange sand**  
**slopes**

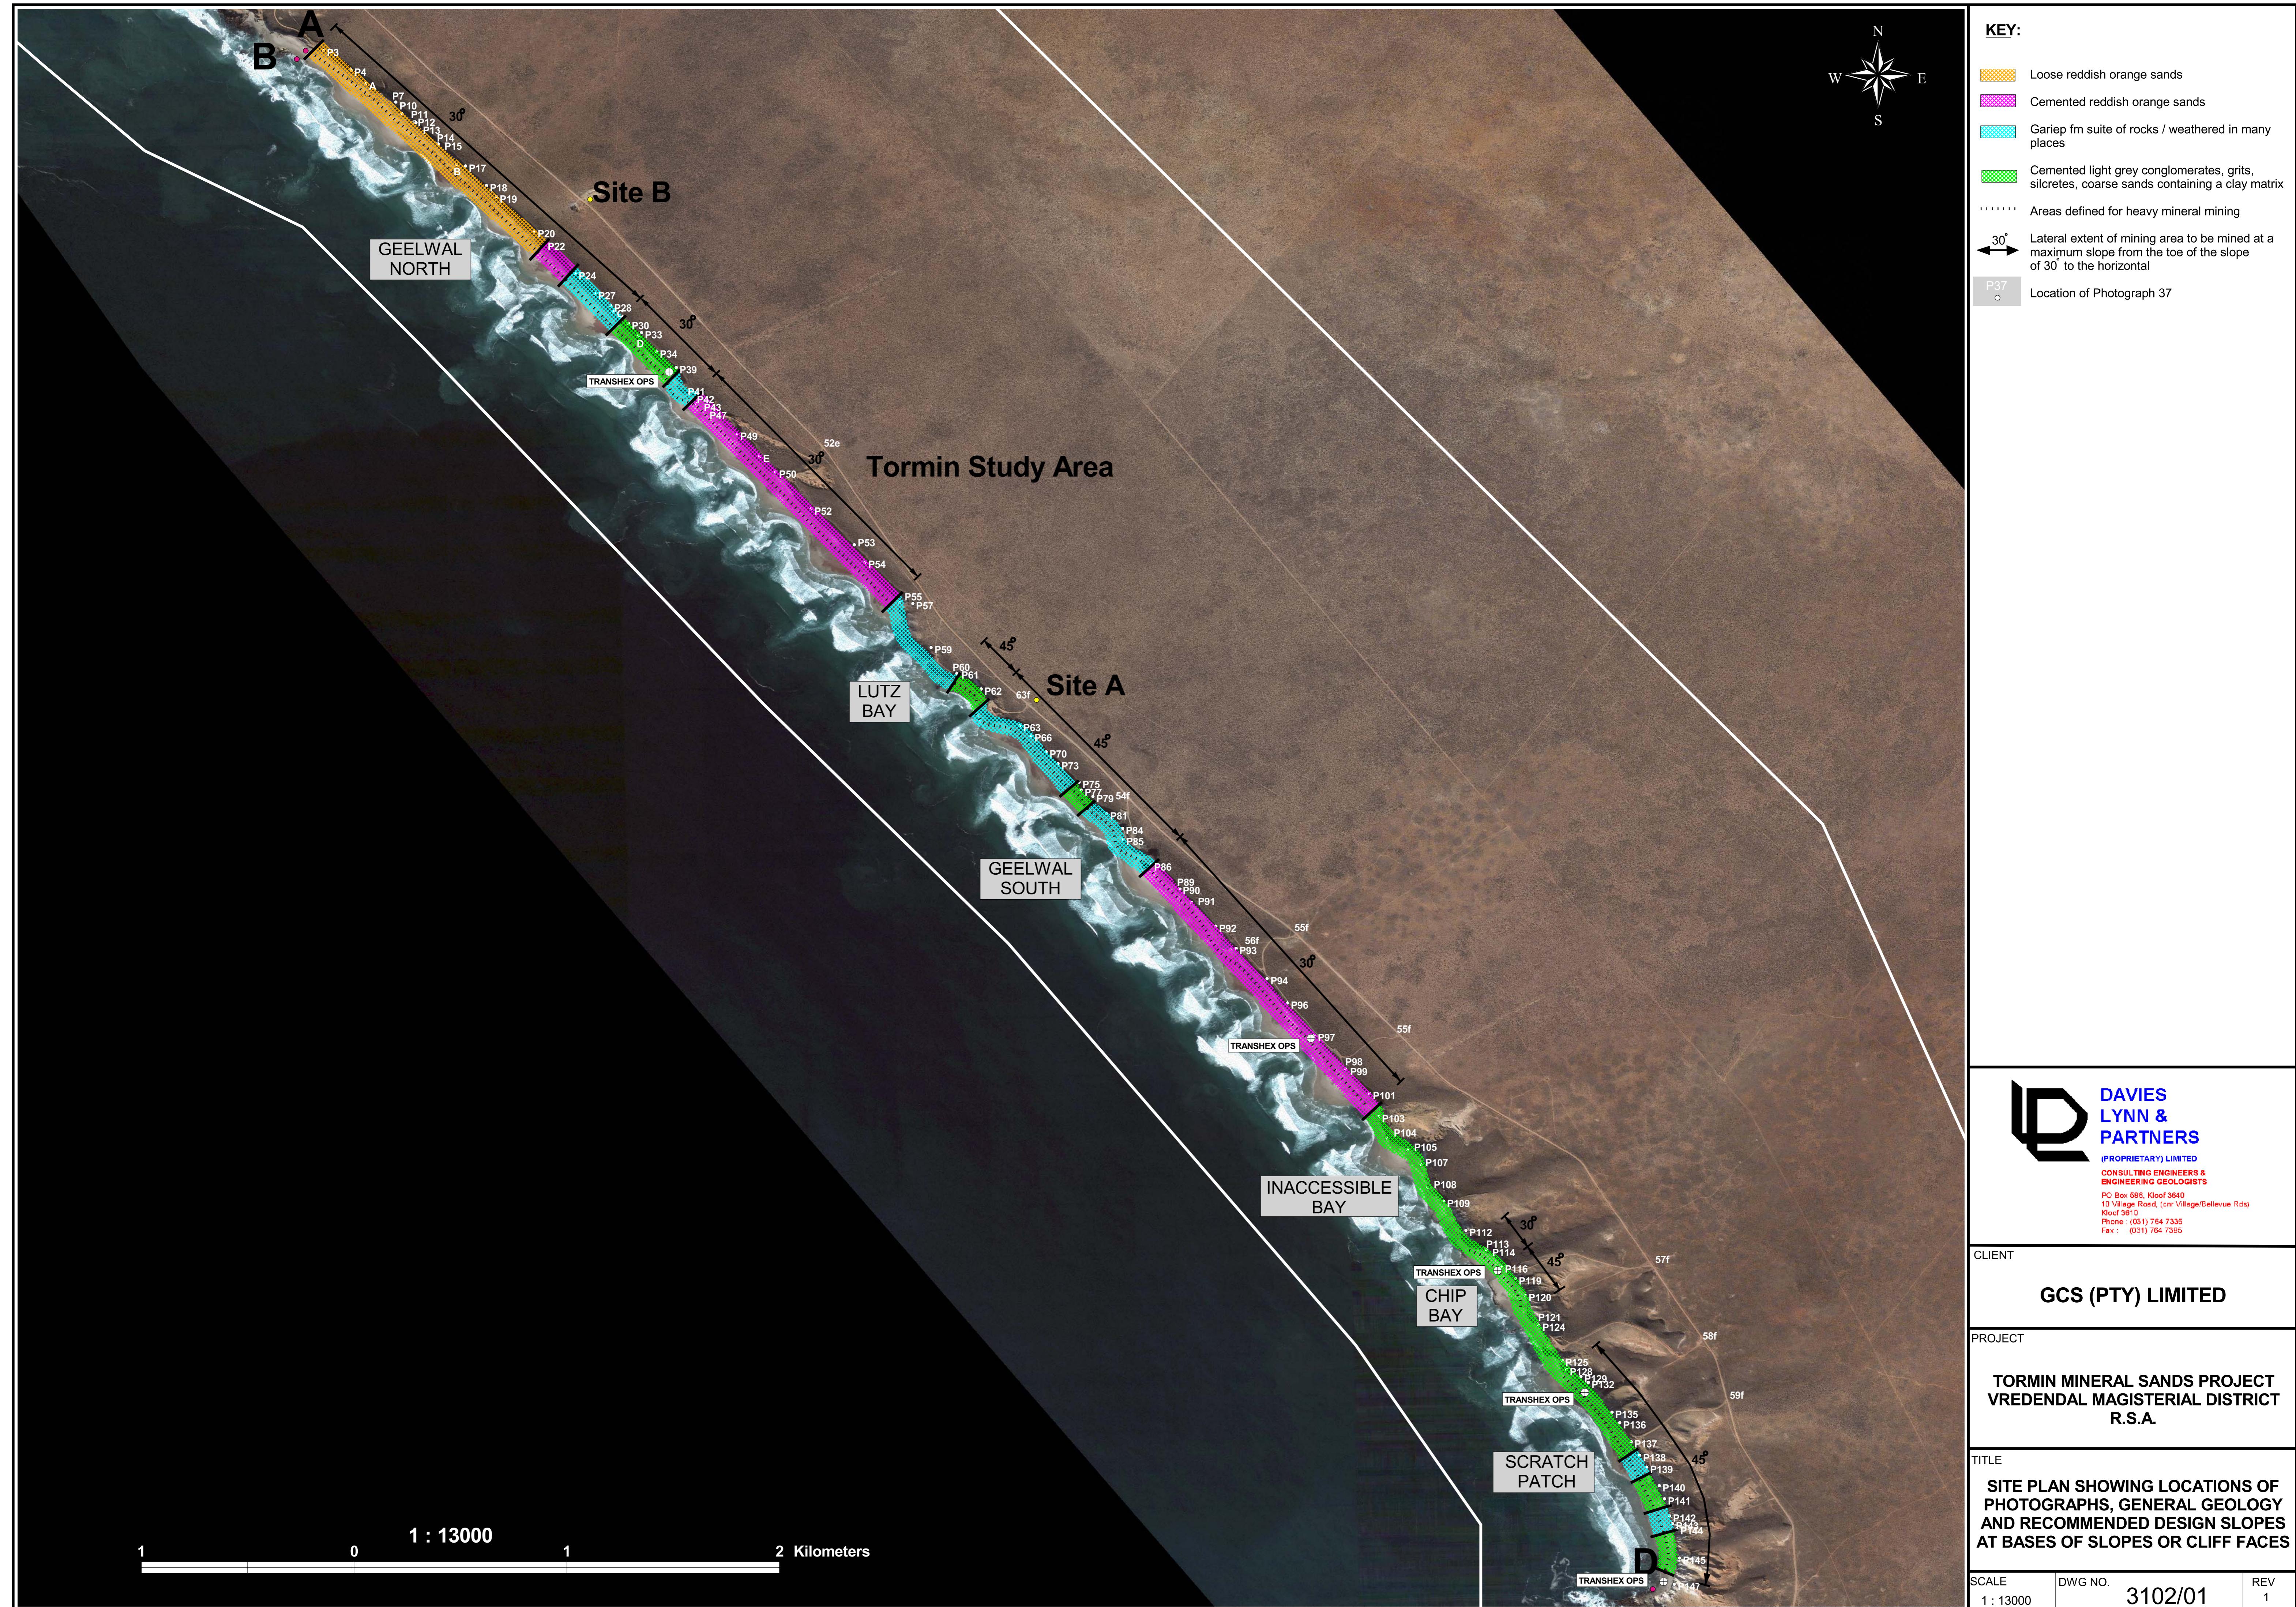
An exception occurs in the Chip Bay area between P113 and P116 as indicated in Dwg. 3102/01 where a 30° offset is applied over a short section rather than the 45 degree offset, considered the lower bound and appropriate for the well cemented light grey sands and gravels. The reason is that within this portion of the Chip Bay area there exists a limited section where the lower slopes are comprised of only slightly cohesive to cohesionless materials containing silcrete blocks.

The recommendations made above have been plotted on to a drawing, Dwg. No. 3102/01, on which is indicated the areas in which either the 30 degrees (1 in 1.75 slope) or 45 degrees (1 in 1 slope) applies. The geological conditions have been colour coded and proposed mining areas named and indicated on the drawing.
