Ecological Impact Assessment Report on the MSR Sand  
Mining Operation, Farm Geelwal Karoo 262, Western Cape  
Coast.

MSR

October 2014

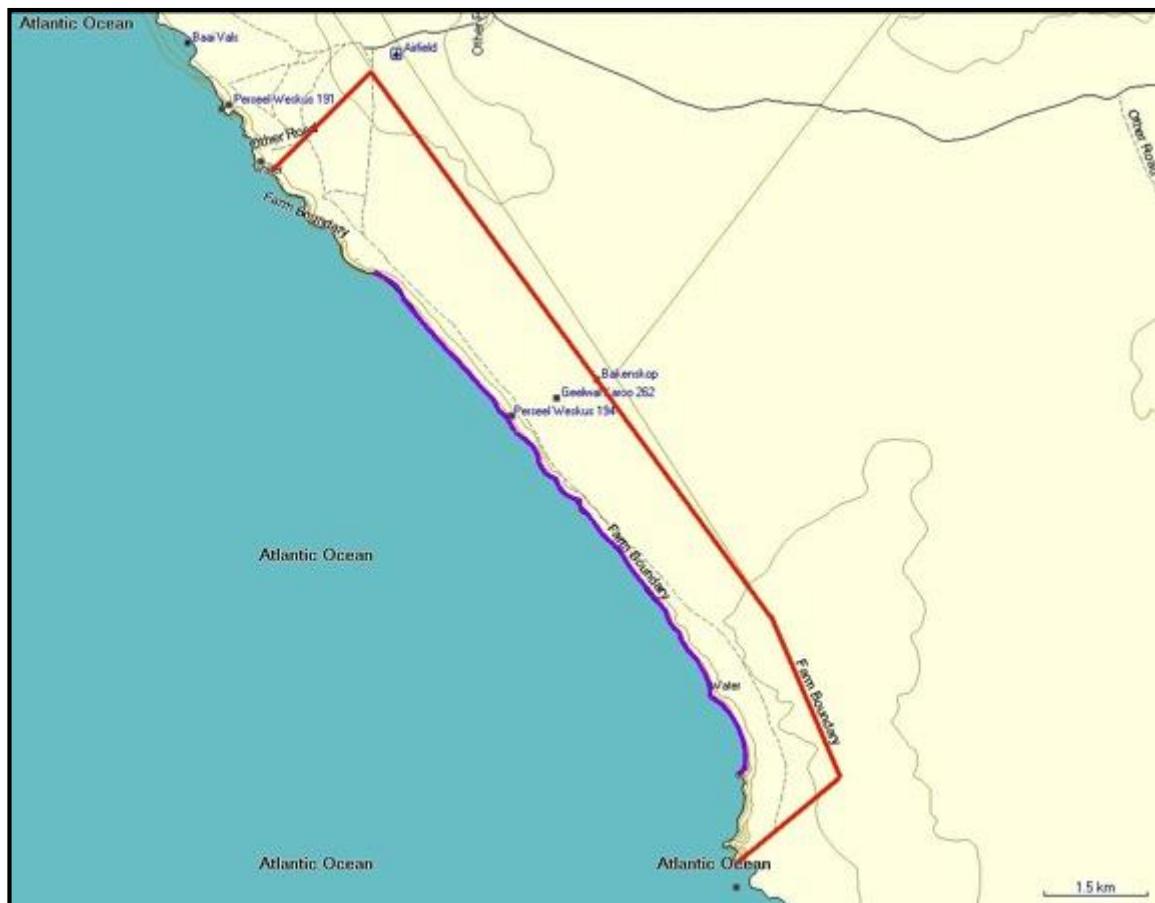
**Figure 1.1: Locality map of the MSR mining licence area with the farm Geelwal Karoo 262 outlined in red and the approved coastal mining zone in purple. (This image has been taken directly from McDonald 2007b, pg 8).**

The study area is situated to the north of the Olifants River mouth, with the planned mining taking place in a 50m wide strip between the low and high water marks on the farm Geelwal Karoo No 262 (ECOSUN 2007a). Figure 1.1 indicates the position of the MSR mining activities.

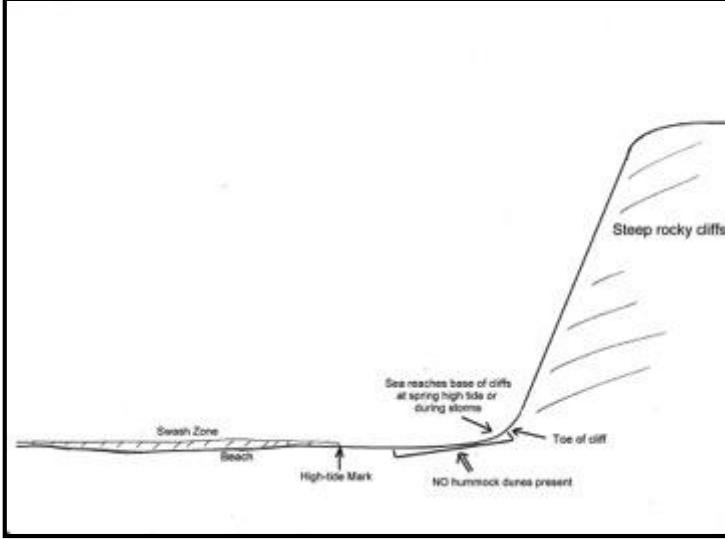
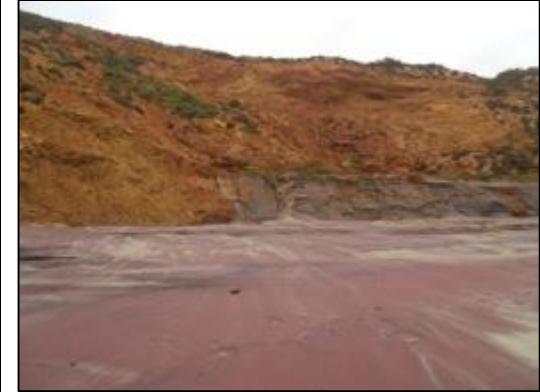
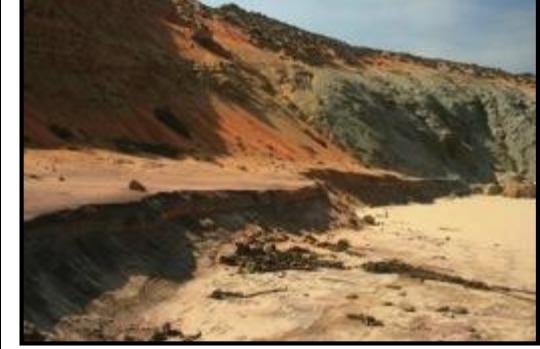
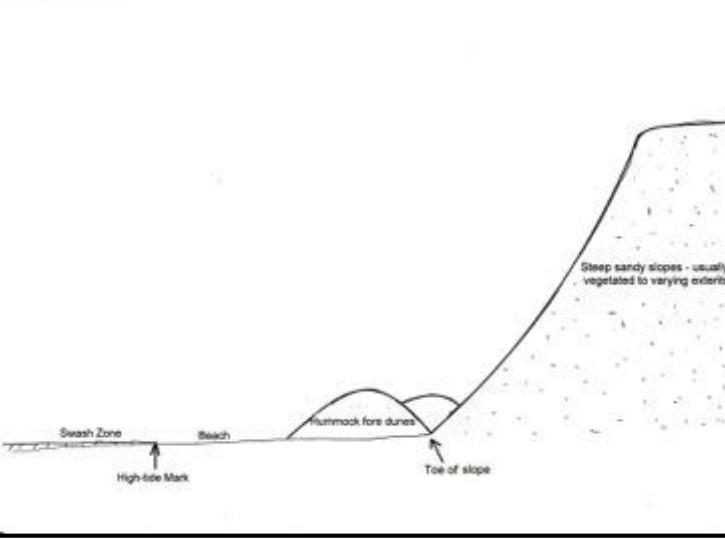
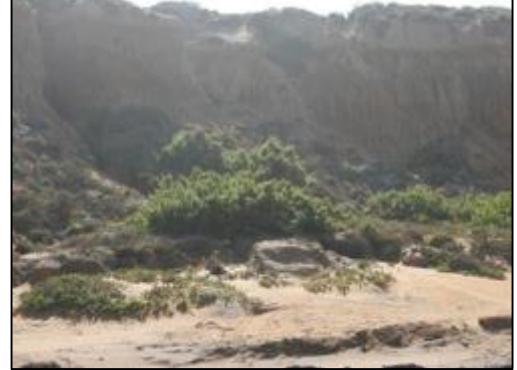
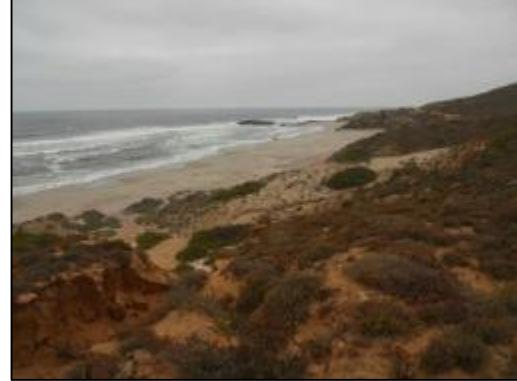
Table 4.1: Types of dune systems along the MSR mining license area.

Dune system type	Description	Diagram (taken from McDonald 2007b pg13)	Example
Steep slopes with no dune formation at the toe	<p>These slopes are generally caused by the natural erosion of the slopes at the interface between the cliffs and the sea. Undermining of the rock by wave action then causes the cliffs to collapse. The resulted sand load is then washed back out to sea. This causes an abrupt change from the toe of the cliff to the flat shore, devoid of vegetation. Depending on sea level, dunes may form in these zones over an extended period of time.</p>

Dune system type	Description	Diagram (taken from McDonald 2007b pg13)	Example
Steep slopes with dune formation at the toe	<p>These steep slopes have collapsed in the past but the high tide line no longer reaches them. This has given the vegetation time to colonize slumped sand and embryo and hummock dunes are formed as a result of this succession process.</p>

Slopes with embryo and hummock dune formation at the base	<p>There are some slopes which are still steep but do not have cliffs. In these areas a typical dune system is formed with embryo dunes forming closest to the high tide mark, hummock dunes and corresponding dune slacks created behind these. Vegetation then changes as the top of the slope and the coastal plain is reached where the climax vegetation becomes dominant.</p>

It is recommended that several transects be done as part of the baseline for the monitoring of the dune systems as required by the EMP for the MSR activities.

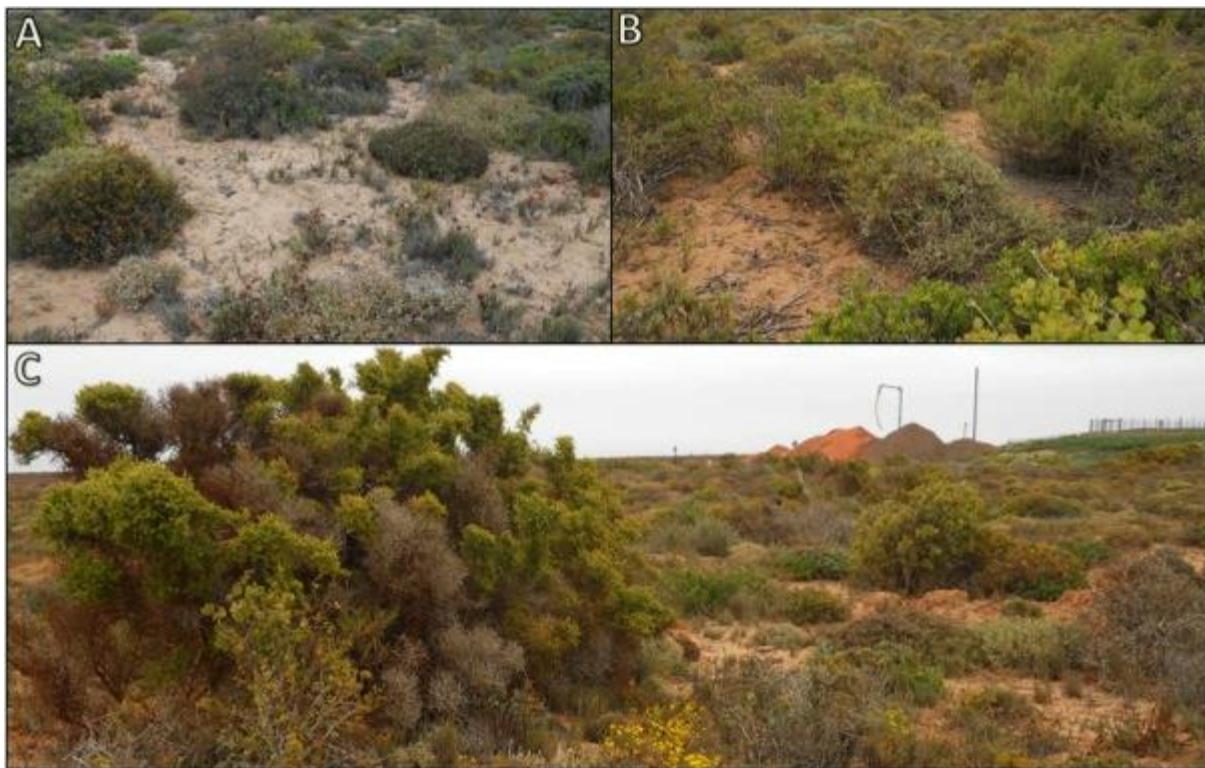
The study indicated that the vegetation changes from the edge of the current haul road close to the beach inland. This change is shown in both species composition as well as plant habit (Figure 4.3). Small (max 50cm) shrubs and Couch Grass (*Cynodon dactylon*) occur closer to the beach on the coastal plain, with much taller shrubs (up to 1.5m) occurring inland. The differentiation of plant communities is a clearly indicates that the coastal plain is part of the dune system of the coast, with climax dune vegetation occurring further inland than previous studies have suggested. This indicates that an approach using transects would be beneficial for the elucidation and mapping of the vegetation types effected by the mining and associated infrastructure and land use.

**Figure 4.3: Vegetation differences at the MSR proposed plant expansion site. A: low vegetation closer to the coast, B: Taller vegetation inland, and C: The difference in height between the taller vegetation (left) and the shorter vegetation (right) in the ecotone zone.**

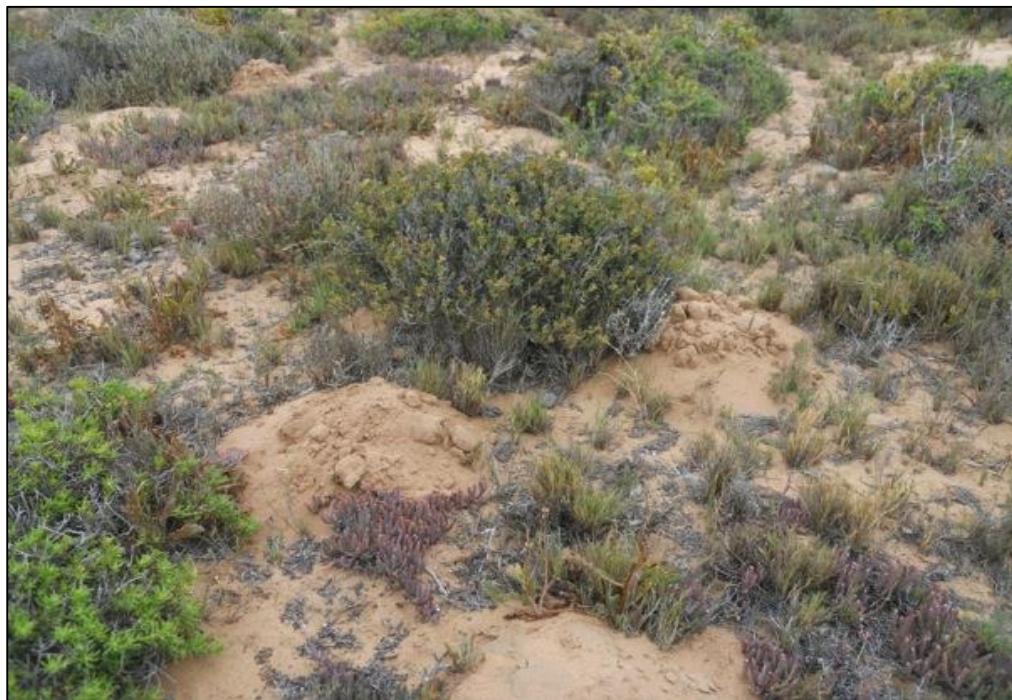
**Figure 4.5: Mole hills observed in the proposed processing plant expansion footprint. Although it is not known which species makes these hills, it is most likely either the Cape Dune Mole-rat (*Bathyergus suillus*) or the Cape Mole-rat (*Georychus capensis*), neither of which are red listed.**

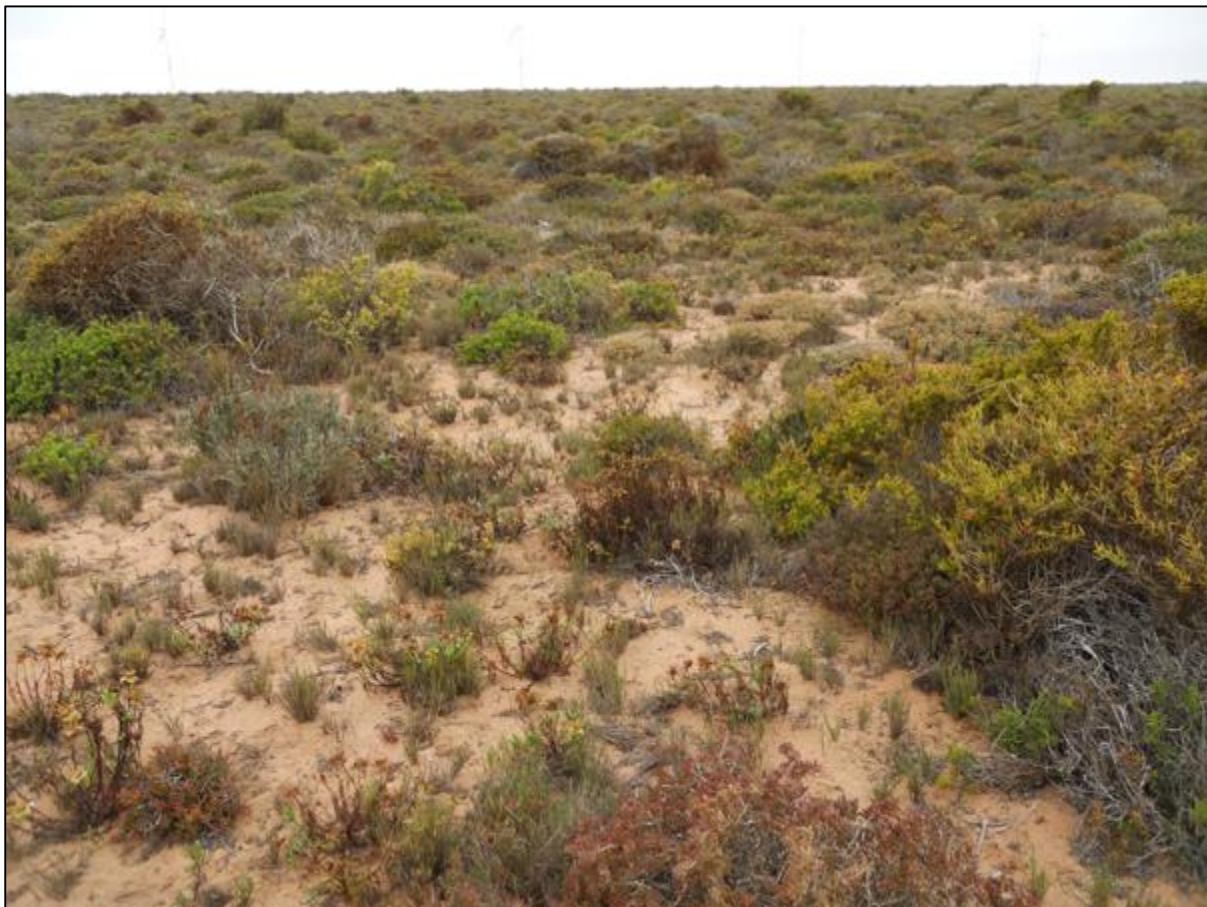
Currently, the land on which the processing plant is situated, as well as the area required for beach access is no longer used for sheep grazing. Sheep farming is the primary previous land use for the Strandveld of the area. As such, the entire area for which access to livestock is restricted, is currently recovering from grazing impacts. Reduction of grazing has resulted in several positive impacts to the vegetation and habitats of this Strandveld. The vegetation is recovering from grazing and several species not recorded from grazing areas have started to recolonize and better stabilize the sand at the processing plant site (Figure 5.1).

**Figure 5.1: Strandveld surrounding the processing plant site showing the recovery, especially of grasses of the vegetation and associated increase in percentage cover.**

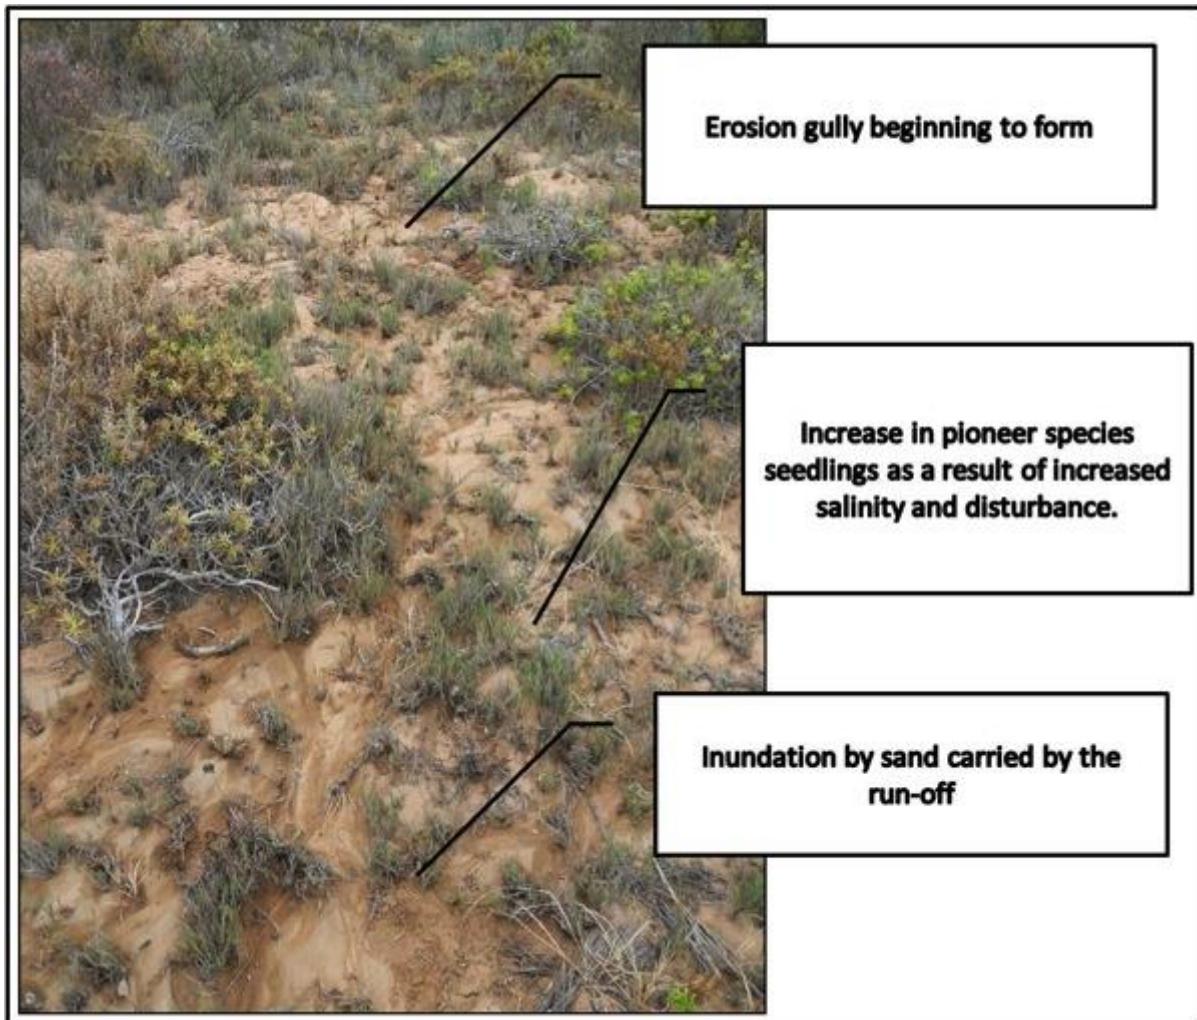
Some impacts are already occurring in the land earmarked for the expansion of the processing plant facility as a result of run-off of water used in processing. This run-off is causing some erosion and negative impacts to vegetation including inundation by loose sand carried by the run-off, and change in vegetation structure due to increased water and increased salinity

(Figure 5.2). These impacts are negligible at this stage. Although these impacts will be eliminated if construction commences, they are likely to occur at the boundaries of the increased processing plant site. It is important that the area is correctly bunded and that run-off is collected and captured and re-used in the process as planned by MSR.

**Figure 4.2: Negligible very low impacts associated with current run-off from the existing processing plant and associated infrastructure.**

Run-off associated change in vegetation composition.	As already noted, run-off, if not properly controlled from the processing plant site will have an impact on the vegetation surrounding the proposed processing plant expansion footprint. This increases the disturbance of the vegetation, as well as increasing sand deposited in top of the existing vegetation. This creates an environment which approximates beach conditions, resulting in a change from Strandveld to dune ecology. As this is likely to have a snowball effect, this impact is likely to be large over the long term.	Moderate negative	In order to mitigate this impact, the area on which salt water is used for processing should be bunded. The water should then be collected, passed through a settling pond to reduce sedimentation and then pumped into the collection ponds to be reused in the processing. Consistent monitoring should ensure no run-off occurs outside of the processing plant site.	No impact

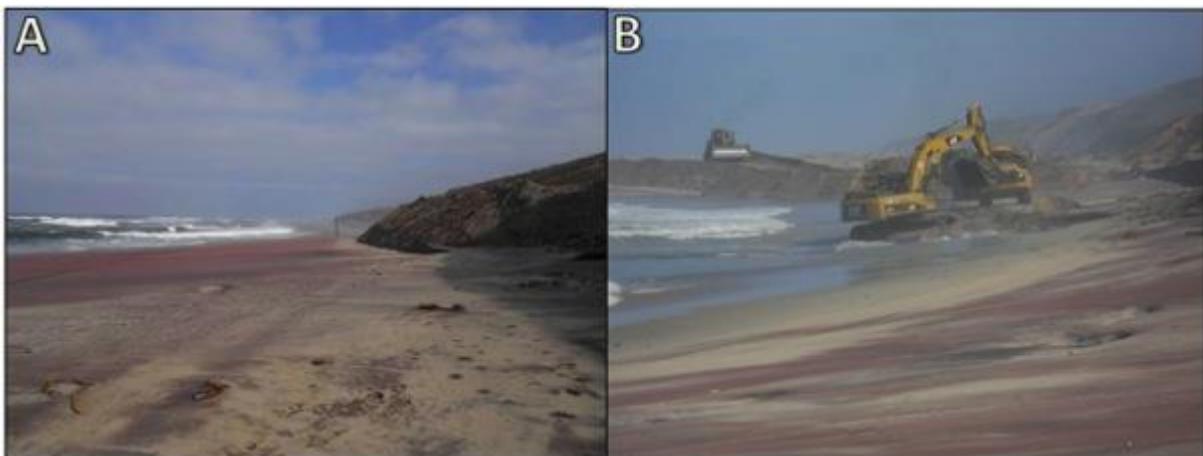
Figure 6.1 below shows the obvious minerals in the sand that MSR are mining, as well as the operation between the 10m buffer zone and the low water mark.

**Figure 6.1: MSR mining activities. A: Minerals within the sands of the beach are obvious. B: The mining activity takes place within a very small footprint at any one time and is restricted to the zone between the low tide mark and the 10m buffer zone from the dune vegetation.**

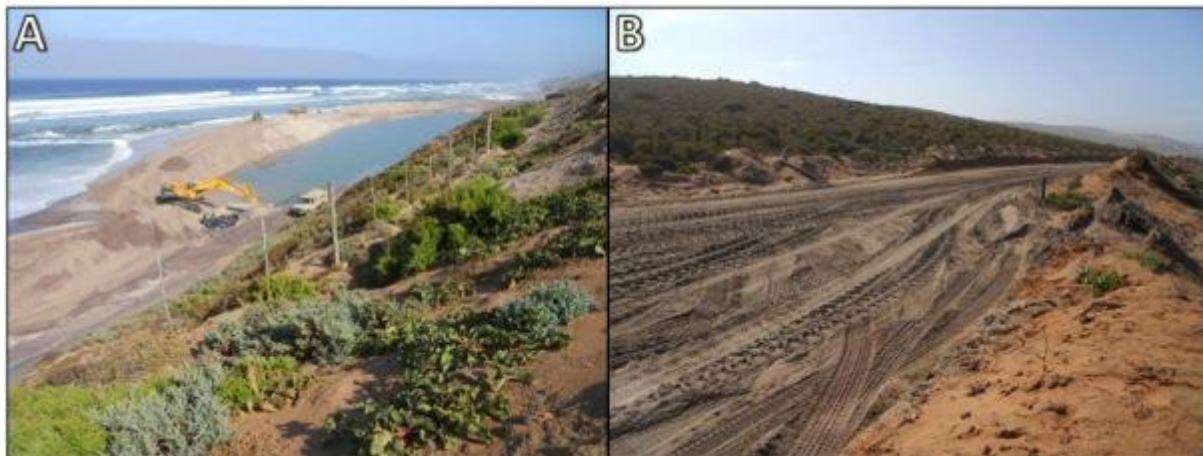
Although the impacts on the beach are very small, MSR have constructed access roads to the beach. These have been constructed mainly over previously existing roads that past mining companies have used for beach access. The result is that both the historical impacts, as well as those caused by MSR on these beach access roads are one and the same. Figure 6.2 shows an example of the beach access roads. There is traffic along these roads in the sensitive vegetation zone between the shoreline and the climax vegetation, it is this important that these roads are managed correctly. Gabions should be constructed to prevent erosion and people must be prevented from walking down the slopes to access the beach. Compaction of the roads is unavoidable, and as many companies are busy mining the area, the roads are likely to be used in the future. The roads should be maintained by all users collectively.

**Figure 6.2: Beach access roads used by MSR. A: a view of the proximity of the access road to the start of the steep slope. B: A beach access road situated on the slope between the cliff and associated dunes and the climax vegetation on the coastal plain.**

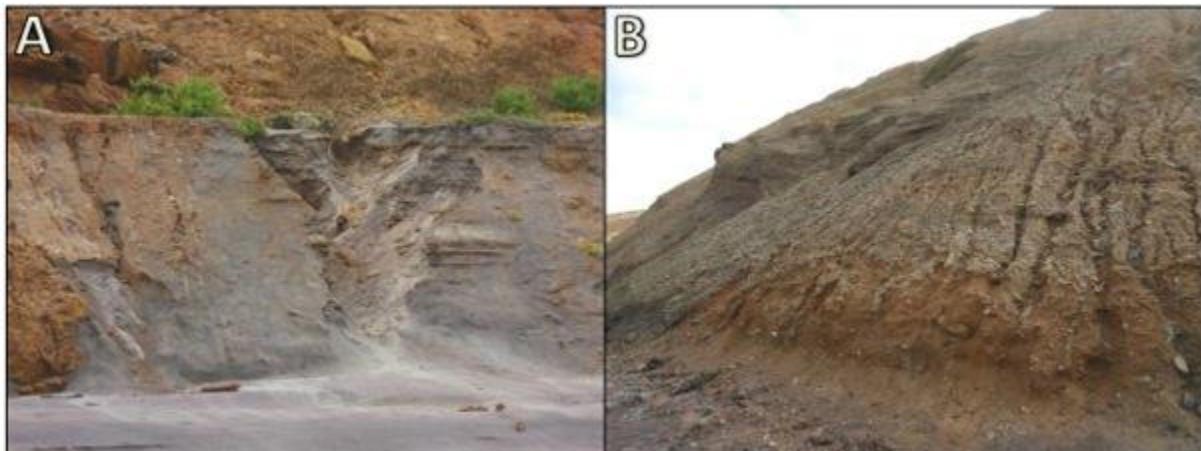
Issue	Description	Figure
Sand erosion on slopes	Where the high tide mark reaches the base of the sea cliffs, sand is eroded away from the slopes. This erosion is also present on shallower slopes where slumped sand has not revegetated due to recent slumping or lack of topsoil due to run-off. Responsibility held by MSR for this issue: none. However, this issue should not be exacerbated by MSR activities and a monitoring plan should be put into place to ensure no additional degradation occurs.	Figure 6.3

**Figure 6.3 Sand erosion present in the study area. A: Sand erosion at the toe of the cliff. B: Sand erosion on slumped sand.**

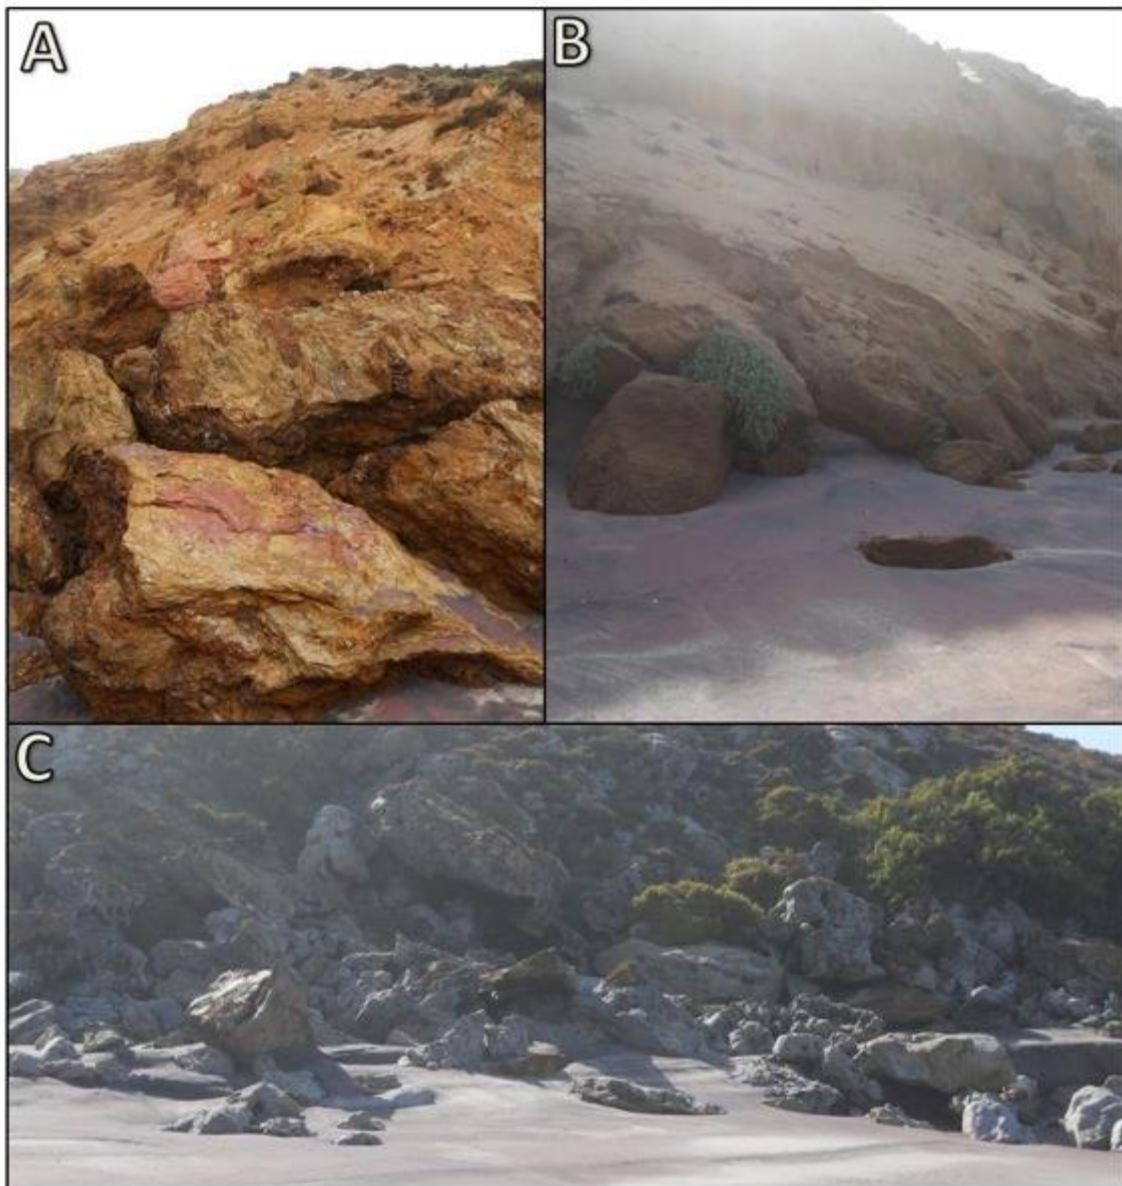
Issue	Description	Figure
Rock falls due to sea erosion of cliff bases	<p>Where the high tide mark reaches the base of the sea cliffs, sand is eroded away from the slopes. This undermines the existing cliffs and the overlaying rock then collapses onto the beach. Depending on the type of rock, this may be eroded away by the sea, or form rocky outcrops with associated fauna and flora.</p> <p>Responsibility held by MSR for this issue: none. However, this issue should not be exacerbated by MSR activities and a monitoring plan should be put into place to ensure no additional degradation occurs.</p>	Figure 6.4
Cliff erosion caused by diamond mining	<p>Although a site visit to the existing diamond mining operation within the license area was not possible, this was seen from the top of the cliffs. It is clear that the impacts have affected the integrity of the existing coastal cliffs.</p> <p>Responsibility held by MSR for this issue: none. However, this issue should not be exacerbated by MSR activities and a monitoring plan should be put into place to ensure no additional degradation occurs.</p>	Figure 6.5 A

**Figure 6.4: A, B and C: Rock falls resulting from cliff undermining by sea water and/or previous mining activities.**

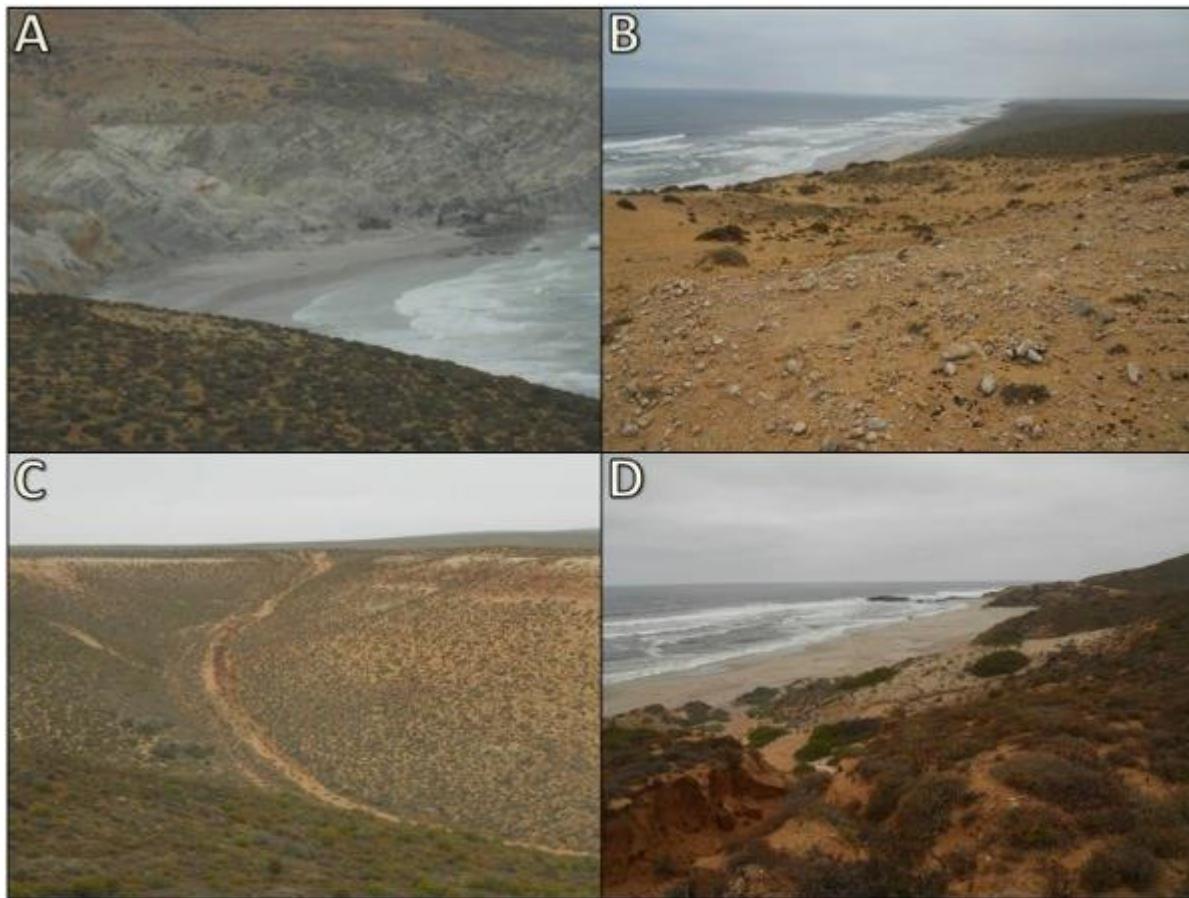
Sand dumps failing to revegetate	<p>Historical mining has left sand dumps along the coastline. Although the exact process that left these dumps is unknown at this stage, it is clear that they the sand has been dumped without an attempt at rehabilitation and the dumps retain no topsoil (evident through rock formations usually present within dunes, not the surface). This is a risk as this could lead to slope slump which may affect MSR activity as well as dune ecology. Erosion is also a factor.</p> <p>Although the responsibility held by MSR for these dumps is zero, and integrated management and monitoring plan developed alongside other operations in the area could result in a best practice objective of leaving the environment in a better state than that prior to mining activities.</p>	Figure 6.5 B
Erosion gullies forming on old beach access routes	<p>Old beach access roads constructed by past mining or farming operations have not revegetated and run-off from the coastal plain has caused serious erosion along these routes.</p> <p>Responsibility held by MSR for this issue: none. This can be partially mitigated by the roads being upgraded for MSR use during mining operations, if this is not planned then the management and monitoring system mentioned above for the sand dumps should be considered.</p>	Figure 6.5 C

Issue	Description	Figure
Sand erosion on old sand dumps	<p>As with the sand dumps and old access roads, erosion has been caused resulting in the loss of topsoil and natural ability of the vegetation to regenerate.</p> <p>Responsibility held by MSR for this issue: none.</p> <p>As above, the management and monitoring system mentioned for the sand dumps should be considered.</p>	Figure 6.5 D

**Figure 6.5: Historical impacts within the study area. A: Cliff erosion and destruction caused by current diamond mining operations. B: Old sand dumps that have failed to regenerate and have little to no topsoil. C: Erosion gully formed from an old beach access road. D: An erosion gully formed on an old sand dump.**

Issue	Management Measure	Responsible person	Timescale	Compliance
	Construction of gabions where required in existing erosion areas (such as old sand dumps)	Construction crew overseen by the mine manager.	A timescale should be determined through a meeting with other mining companies.	Yes/No
	Application of topsoil and shade cloth “walls” in areas failing to revegetate.	Construction crew overseen by the environmental control officer.	This should be done as soon as possible through a meeting with other mining companies. It is recommended that the “walls” remain up until at least a 60% cover is reached.	Yes/No
	Restriction of beach driving to specific tracks. These should be marked out for the monthly operations and adhered to.	Environmental Control Officer.	For current mining, this should be done by the <b>31<sup>st</sup> of October 2014</b> , and from then ongoing.	Yes/No
	Clearly marking the 10m buffer zone from the dune vegetation with stakes and danger tape.	Environmental Control Officer	This should be done <b>monthly</b> depending on the location of mining and to avoid the loss of markers due to wave action. As well as allowing for change in such a dynamic system.	Yes/No
